Inspection Report

123 Main Street, Orlando, FL 34711

Date: 01/31/24

My Inspection Boss

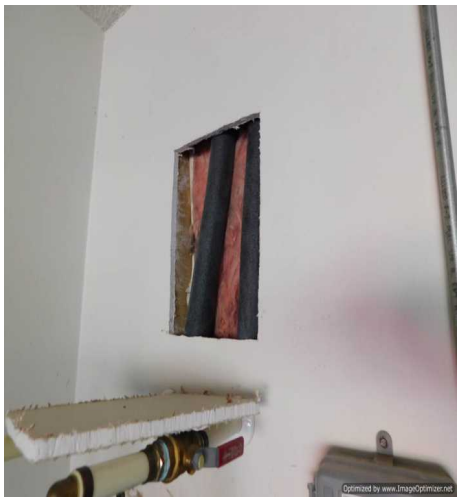
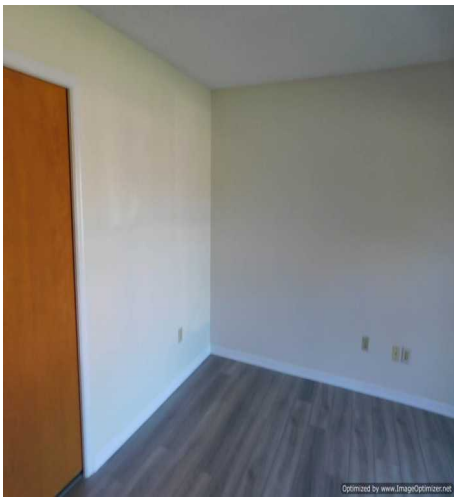
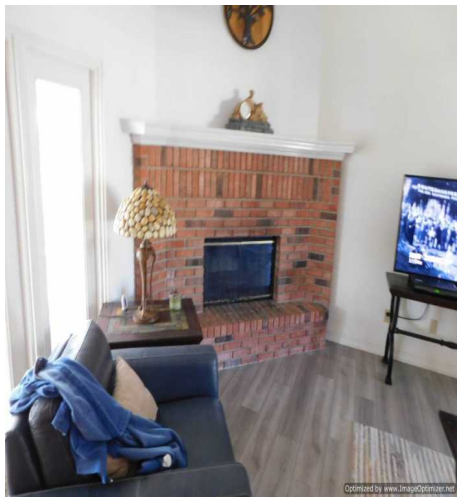
Walls (Interior)

Correction Needed	Minor Repair Needed
Material	Drywall
Comment	Minor holes throughout. The wall needs to be repaired above the water heater. Noted: The fireplace should be cleaned by a professional.

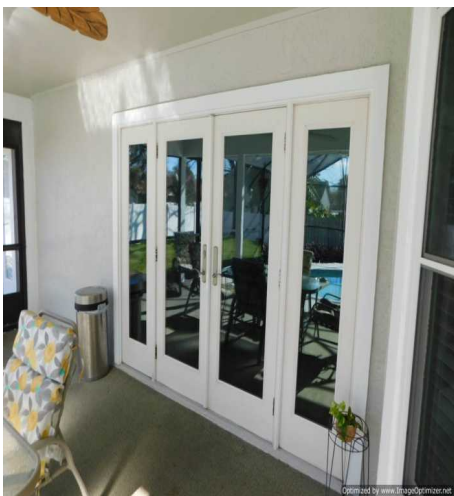
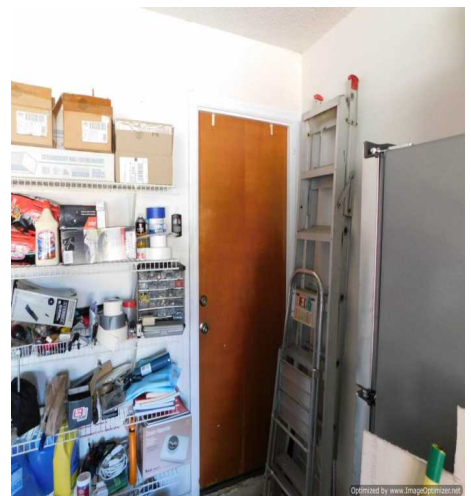
Door(s) (Interior & Exterior)

Monitor Conditions		Recommend Repair	
General Condition of Doors	Satisfactory		
Interior room door condition	Inspected	Interior room door type:	Hollow core (flat panel)
Front home door condition	Inspected	Front home door type	Metal
Exterior door/slider condition	Inspected	Exterior door/ slider type	Metal/Glass
Closet door condition	Inspected	Closet door type	Bifold and Panel
Comment	2+ Interior door stops are missing. Noted: A interior door was missing from the master bedroom to the bathroom.

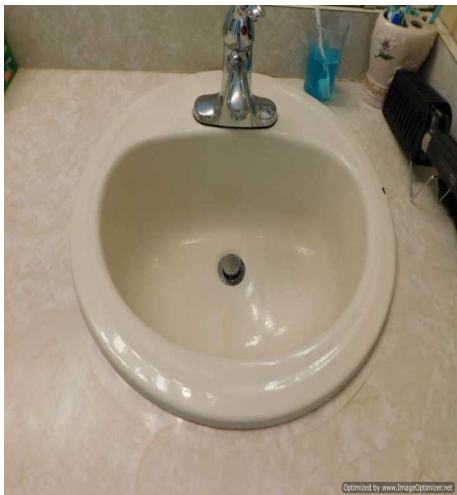
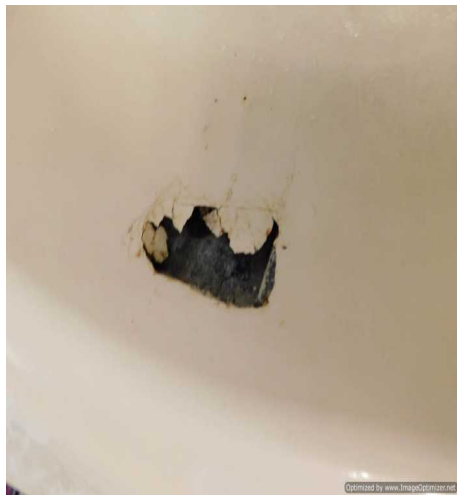
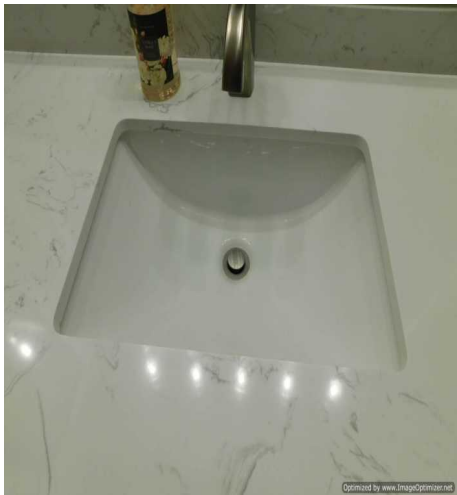
Correction Needed		Recommend Replacement	
Sink Stopper	Yes	Hot/cold lines are reversed	No
Comment	One master bathroom sink needs to be replaced - Rusted.

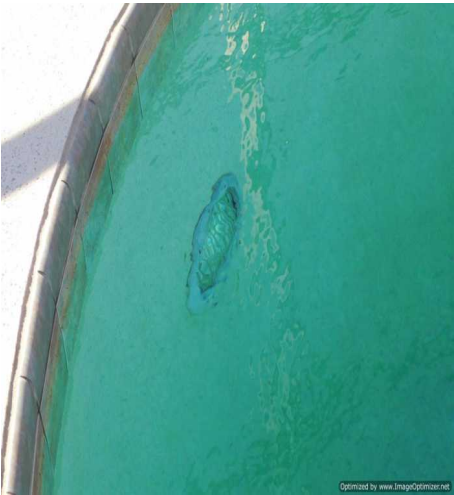
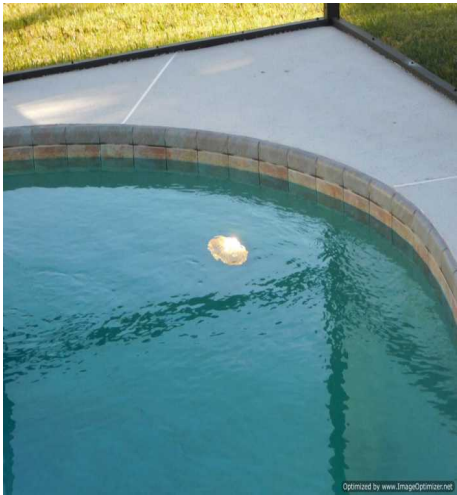
Structure Condition, Decking and Coping

Monitor Conditions		Recommend Repair	
Material	Gunitite and poured concrete		
Comment	Concrete settling cracks were observed on the exterior pool decking. Patches were observed by the main drain on the interior of the pool. Minor stains were observed on the interior pool surface.
