Inspection Report

123 Main Street, Orlando, FL 34711

Date: 01/31/24

My Inspection Boss

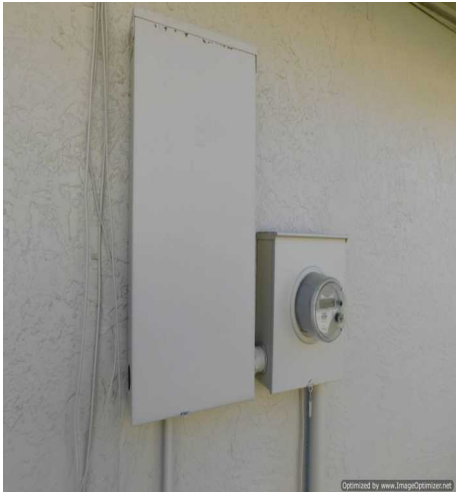
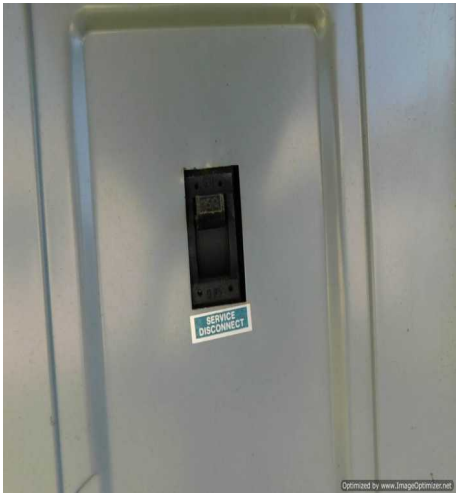
Electrical Service Connection and Components

Inspected	Satisfactory / Fair		
Main panel location	Inside of the garage	Main Cut off Switch Location	Main Panel Exterior wall of the home
Service size main panel	120/ 240 Volt	Services connection	Public Utilities (Underground Service)
Type of wiring	Copper	Amp	150 Amp
Grounded	Yes		
Comment	Noted: The hole on the exterior panel should be plugged.

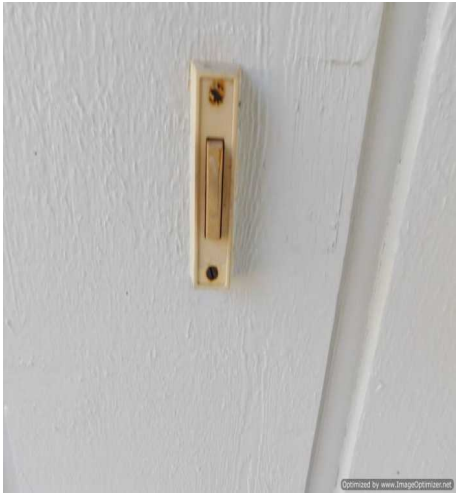
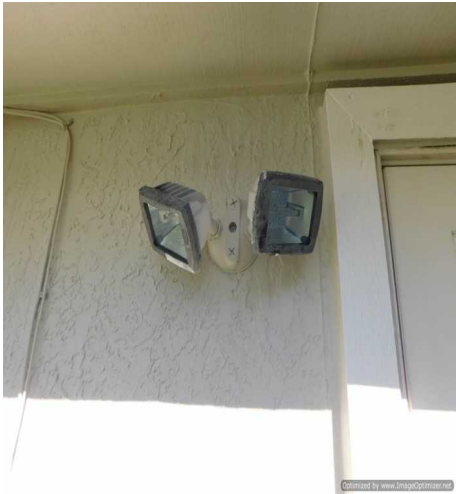
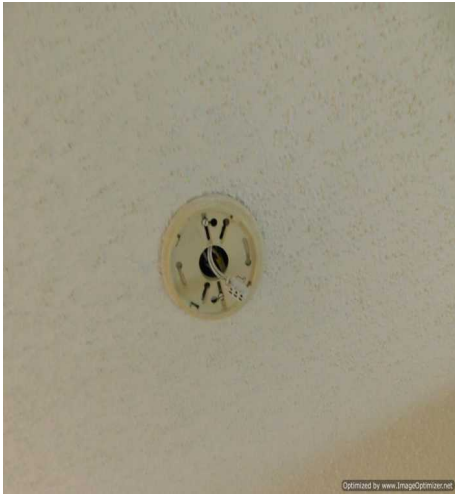
GFCI/Outlets/Smoke Detectors/ Door Bells and Miscellaneous

Correction Needed		Repair Needed	
GFCI	Functional	Outlets	3 prong
Smoke detectors	Replace	Door bell	Functional
Comment	The smoke detectors need to be replaced with photoelectric smoke detectors. The exterior fixtures need to be sealed. No GFCI outlets are noted in the wet area of the kitchen.

Electrical: Exterior and interior general areas : Correction Needed

- The smoke detectors need to be replaced with photoelectric smoke detectors. The exterior fixtures need to be sealed. No GFCI outlets are noted in the wet area of the kitchen.

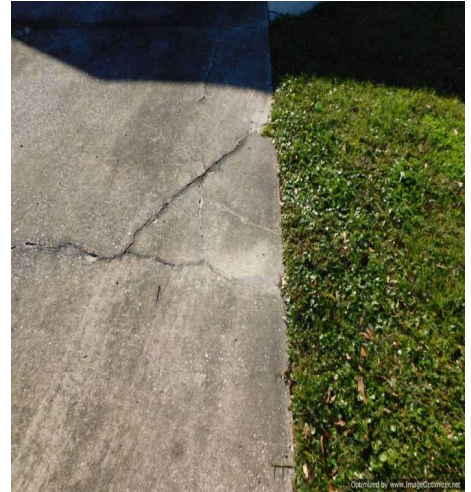
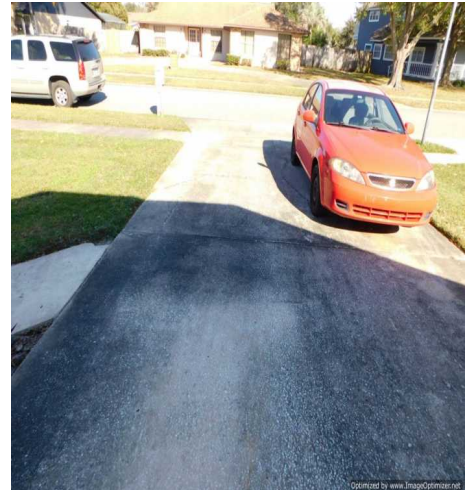
Driveway / Sidewalks

Stress cracks were observed.

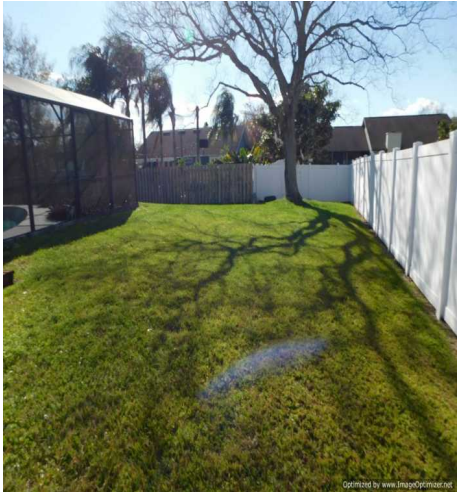
Grading / Slope

Inspected		Satisfactory
Grading issues?	No	
Comment	Noted: Additional gutters are recommended.

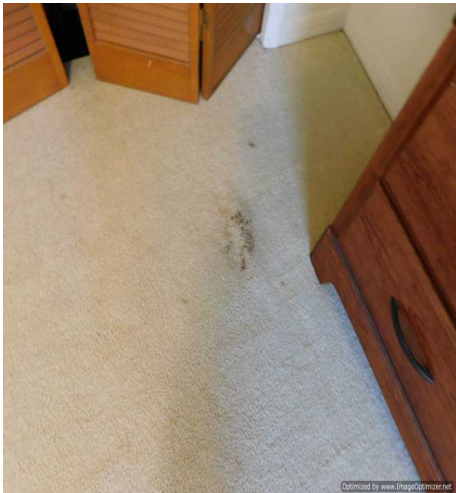
Floors

- Carpet damage was observed in one bedroom. Carpet stains were noted.

Correction Needed	Repair Needed
Material	Carpet, Vinyl planking and Tile
Comment	Carpet damage was observed in one bedroom. Carpet stains were noted.

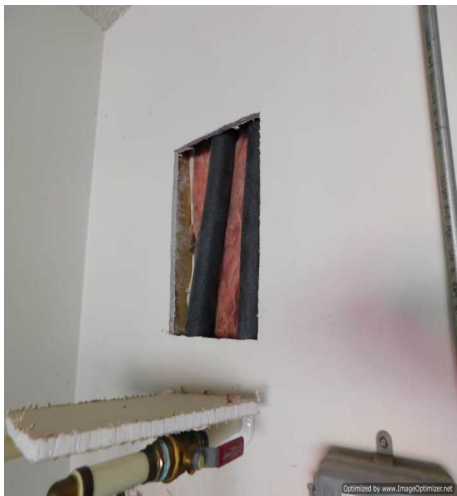
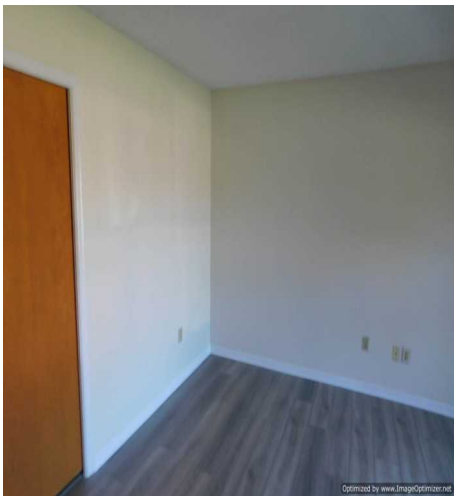
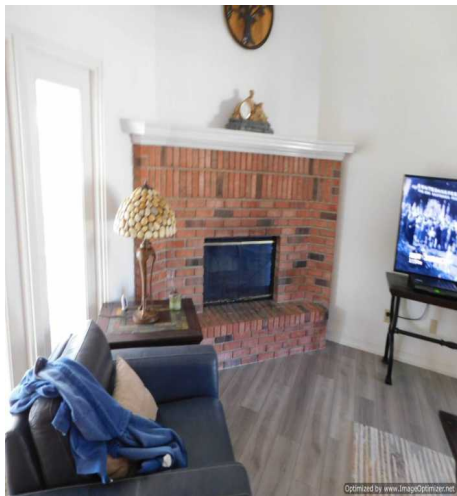
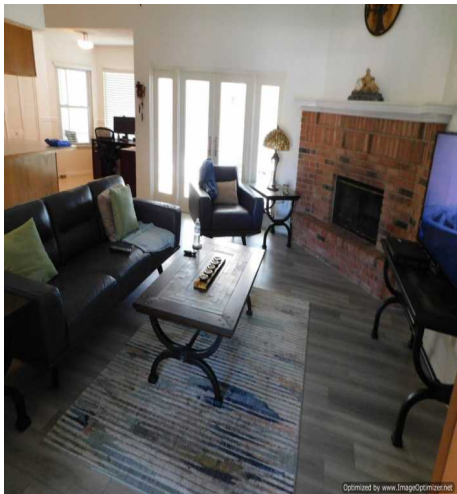
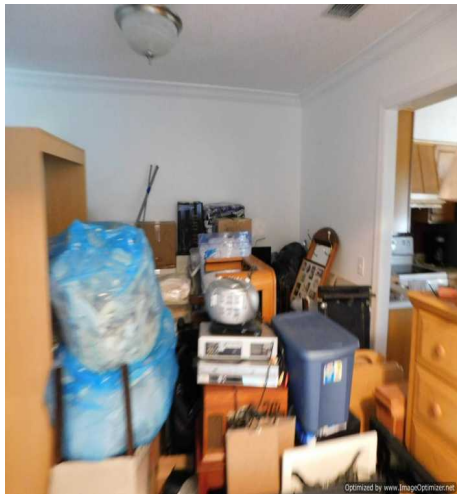
Walls (Interior)

- Minor holes throughout. The wall needs to be repaired above the water heater. Noted: The fireplace should be cleaned by a professional.

Correction Needed	Minor Repair Needed
Material	Drywall
Comment	Minor holes throughout. The wall needs to be repaired above the water heater. Noted: The fireplace should be cleaned by a professional.

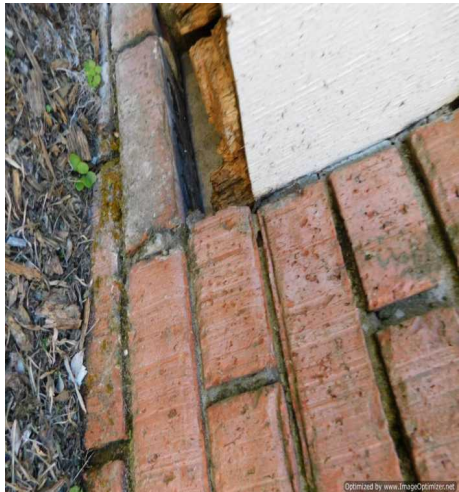
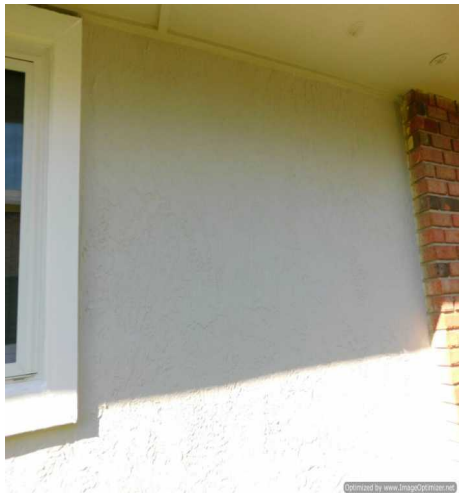
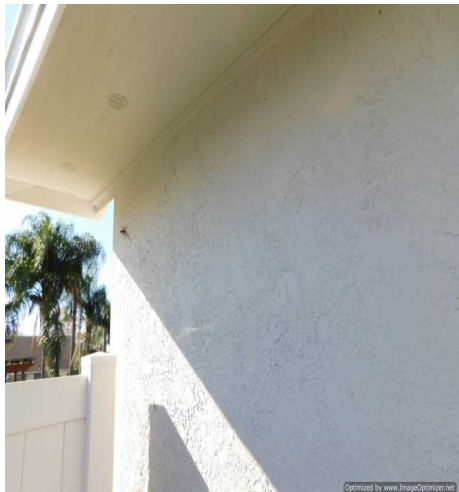
Walls (Exterior)

- The front wood side post next to the windows should be sealed at the bottom.

Monitor Conditions		Recommend Repair	
Material	Stucco, Brick and Wood siding		
Comment	The front wood side post next to the windows should be sealed at the bottom.

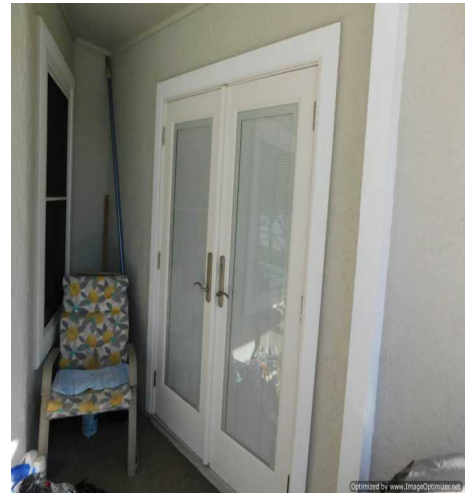
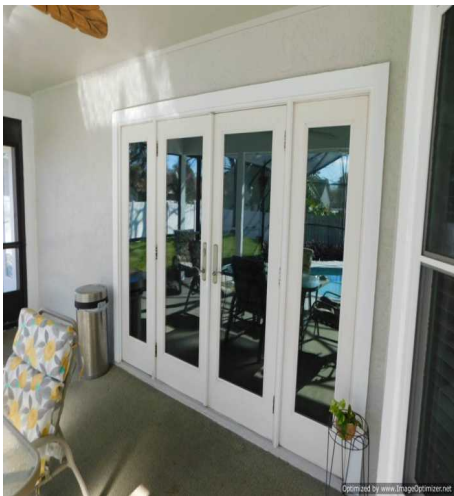
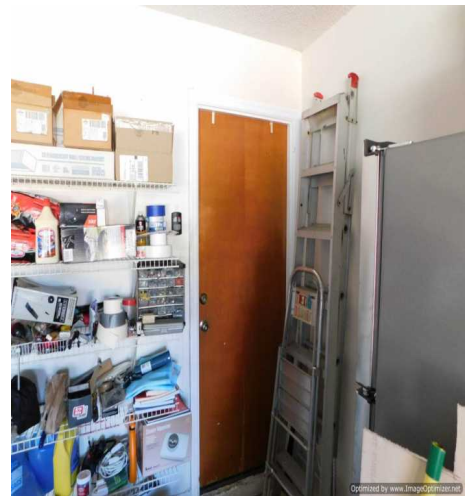
Door(s) (Interior & Exterior)

- 2+ Interior door stops are missing. Noted: A interior door was missing from the master bedroom to the bathroom.

Monitor Conditions		Recommend Repair	
General Condition of Doors	Satisfactory		
Interior room door condition	Inspected	Interior room door type:	Hollow core (flat panel)
Front home door condition	Inspected	Front home door type	Metal
Exterior door/slider condition	Inspected	Exterior door/ slider type	Metal/Glass
Closet door condition	Inspected	Closet door type	Bifold and Panel
Comment	2+ Interior door stops are missing. Noted: A interior door was missing from the master bedroom to the bathroom.

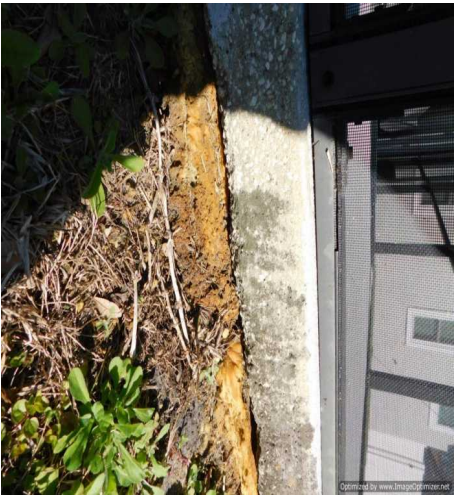
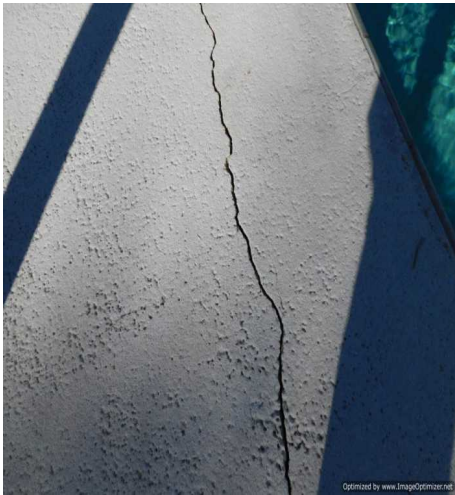
Pool Enclosure/ Patio

- Concrete settling cracks were noted - One patio's edge was spray-foamed on the exterior. The cracks need to be sealed - Ask the seller for documentation. Sill plates need securing - 3+ Bolts are rusted/missing. 2+ Tie-downs need adjusting.

Correction Needed	Repair Needed
Material	Metal, Aluminum and Concrete
Comment	Concrete settling cracks were noted - One patio's edge was spray-foamed on the exterior. The cracks need to be sealed - Ask the seller for documentation. Sill plates need securing - 3+ Bolts are rusted/missing. 2+ Tie-downs need adjusting.

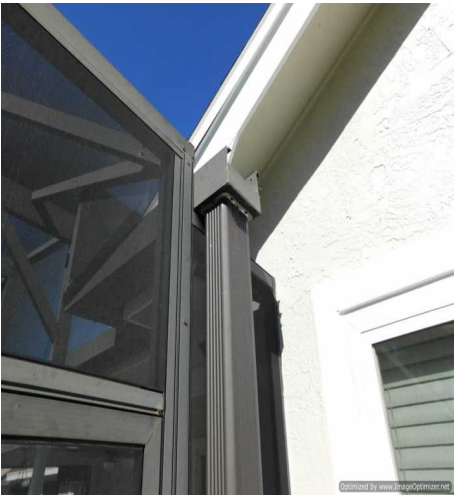
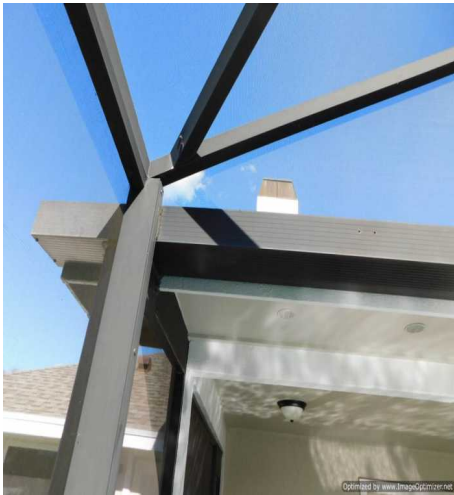
Gutters and Down Spouts

Inspected		Satisfactory
Material	Metal and aluminum	
Comment	Noted: Recommend getting additional gutters.

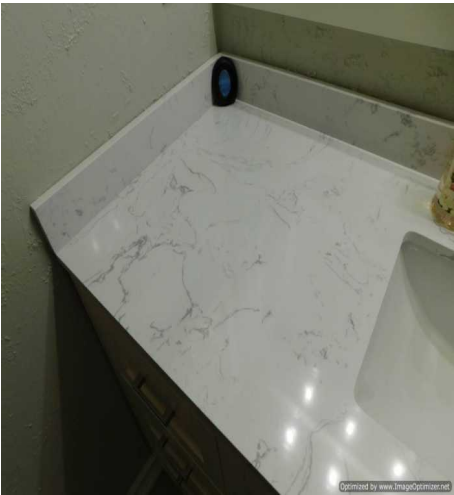
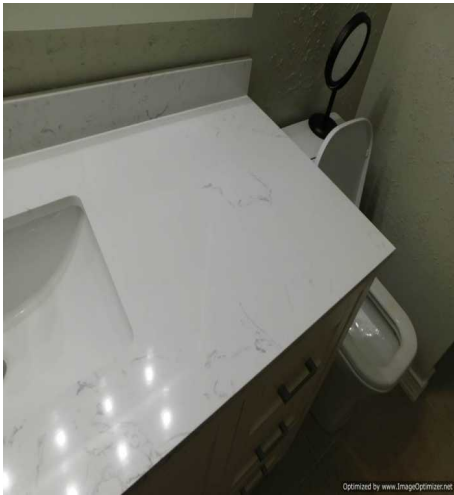
- One master bathroom sink needs to be replaced - Rusted.

Correction Needed		Recommend Replacement	
Sink Stopper	Yes	Hot/cold lines are reversed	No
Comment	One master bathroom sink needs to be replaced - Rusted.

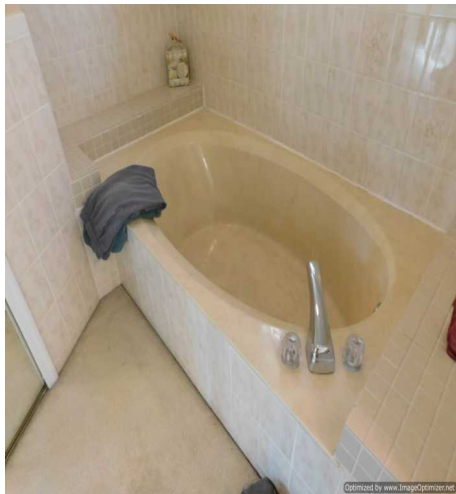
Shower/Tub

- The shower and tub surrounds need to be sealed.

Correction Needed		Minor Repair Needed	
Type	Faux Marble and Fiberglass	Tub Stopper	Yes
H/C lines reversed	No	Tub Diverter valve working	Yes
Shower stall needs sealing	Yes	Shower head is missing	No
Comment	The shower and tub surrounds need to be sealed.

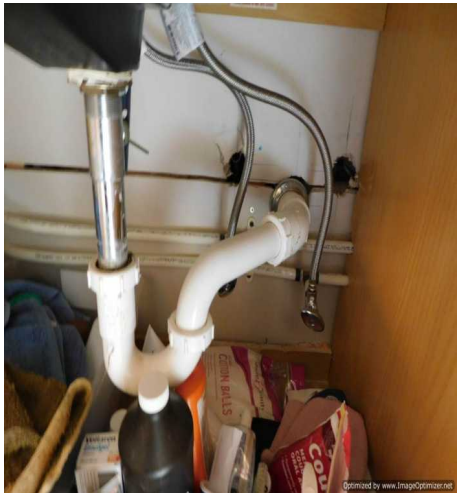
Bathroom Plumbing and Electrical

Inspected		Satisfactory
Material	PVC and PEX	
Comment	Noted: Seal ll the old piping.

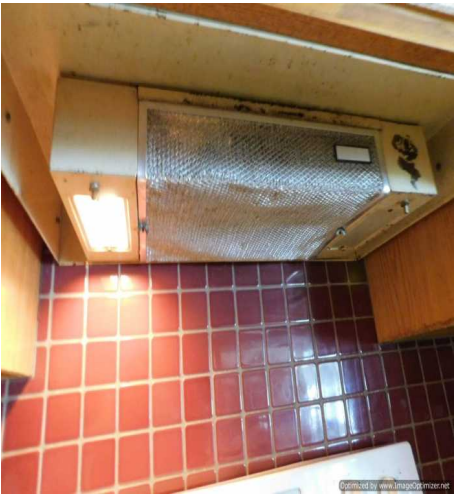
Microwave/ Exhaust

- The unit is older and one light was not functional.

Monitor Conditions		Recommend Repair	
Location	Kitchen	Brand	Veint-Air
Comment	The unit is older and one light was not functional.

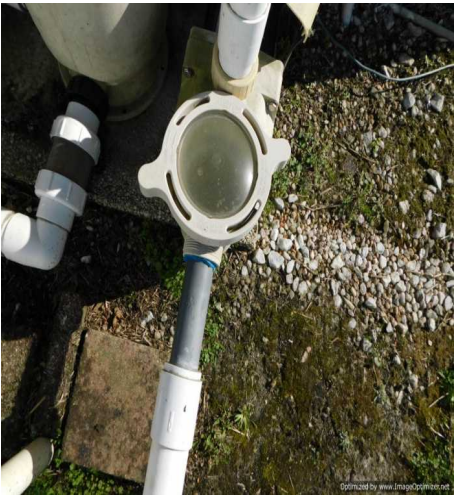
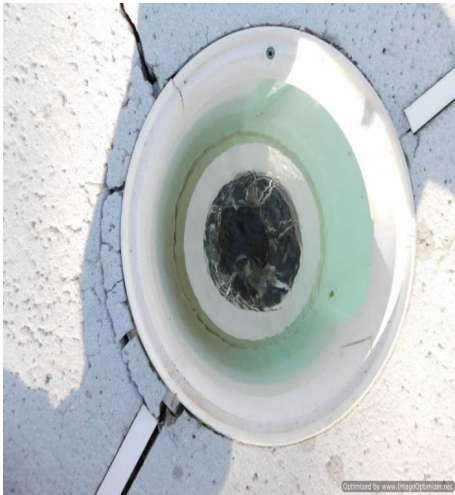
Structure Condition, Decking and Coping

- Concrete settling cracks were observed on the exterior pool decking. Patches were observed by the main drain on the interior of the pool. Minor stains were observed on the interior pool surface.

Monitor Conditions		Recommend Repair	
Material	Gunitite and poured concrete		
Comment	Concrete settling cracks were observed on the exterior pool decking. Patches were observed by the main drain on the interior of the pool. Minor stains were observed on the interior pool surface.

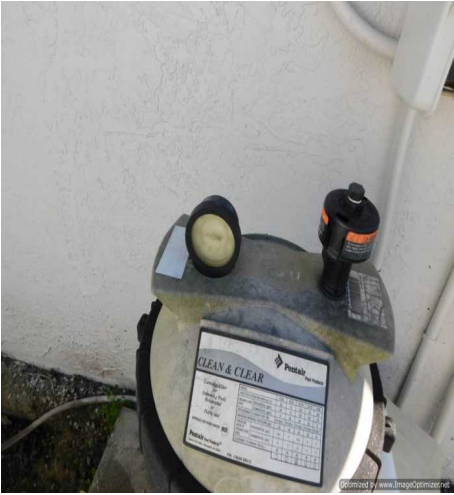
Pressure Gauge/ Drain covers

- No drain release pipe was observed on the exterior of the pool.

Monitor Conditions	Recommend Repair
Yes	
Comment	No drain release pipe was observed on the exterior of the pool.
