Inspection Report

123 Main Street, Orlando, FL 34711

Date: 01/31/24

My Inspection Boss

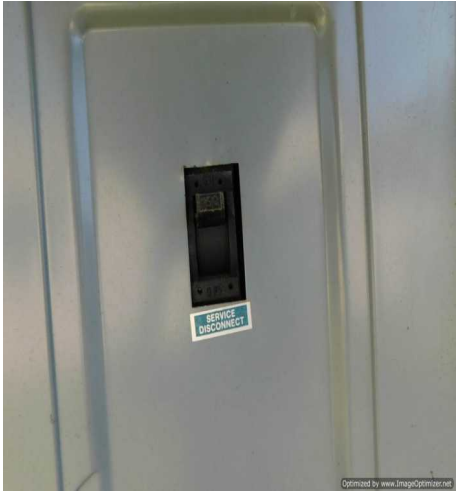
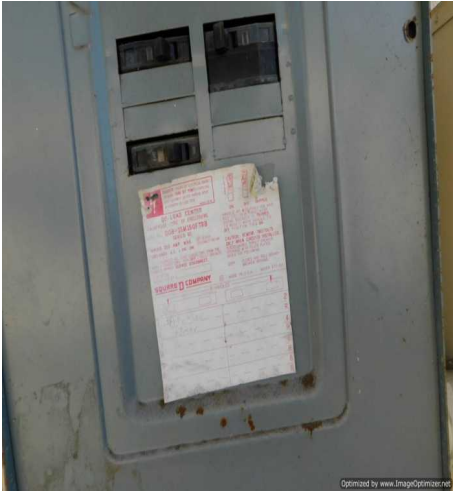
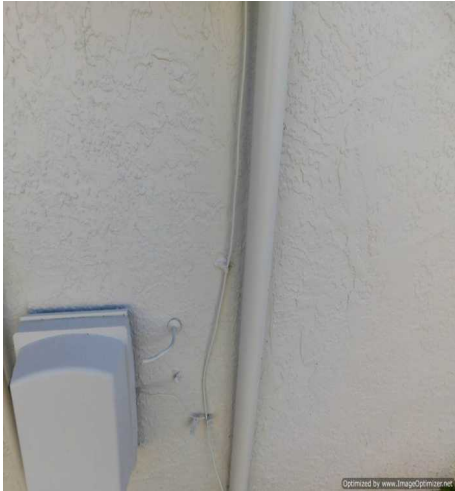
Inspected	Satisfactory / Fair		
Main panel location	Inside of the garage	Main Cut off Switch Location	Main Panel Exterior wall of the home
Service size main panel	120/ 240 Volt	Services connection	Public Utilities (Underground Service)
Type of wiring	Copper	Amp	150 Amp
Grounded	Yes		
Comment	Noted: The hole on the exterior panel should be plugged.

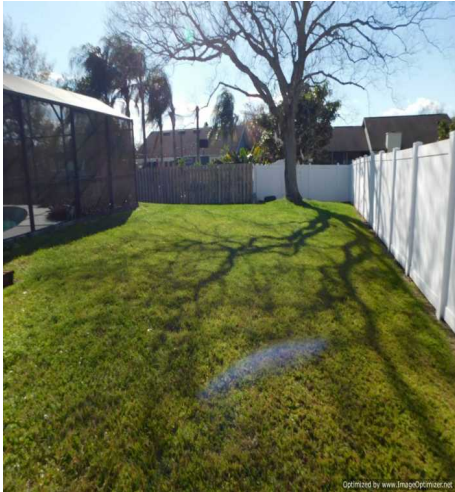
Grading / Slope

Inspected		Satisfactory
Grading issues?	No	
Comment	Noted: Additional gutters are recommended.

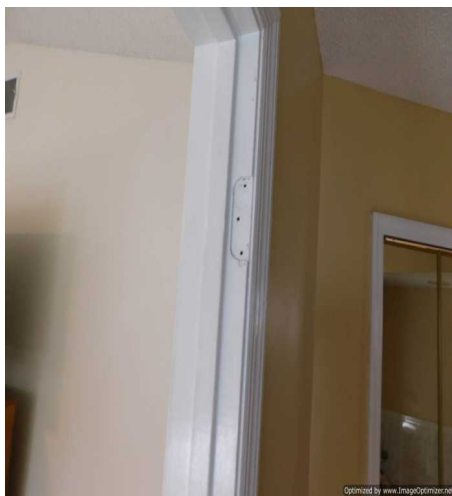
Door(s) (Interior & Exterior)

Monitor Conditions		Recommend Repair	
General Condition of Doors	Satisfactory		
Interior room door condition	Inspected	Interior room door type:	Hollow core (flat panel)
Front home door condition	Inspected	Front home door type	Metal
Exterior door/slider condition	Inspected	Exterior door/ slider type	Metal/Glass
Closet door condition	Inspected	Closet door type	Bifold and Panel
Comment	2+ Interior door stops are missing. Noted: A interior door was missing from the master bedroom to the bathroom.

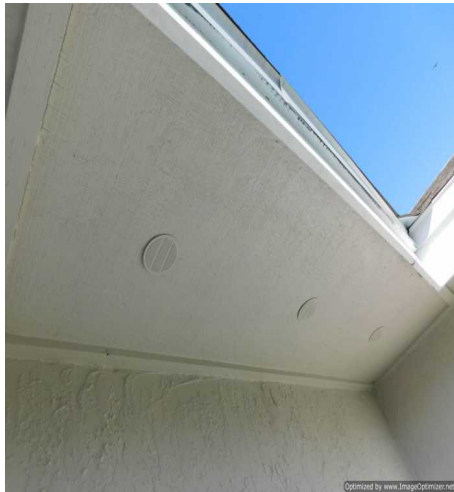
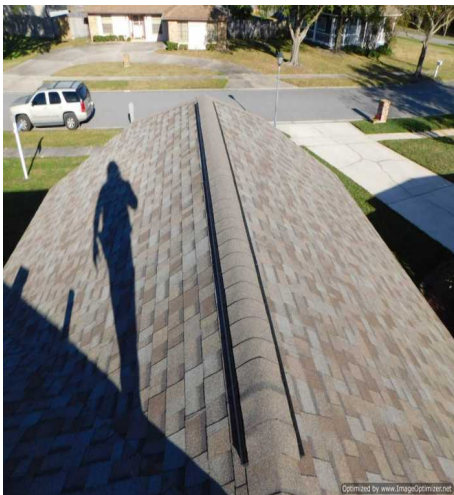
Inspected		Satisfactory	
Ventilation Type	Soffit and Ridge		
Comment	No concerns were observed.		
<div><div>

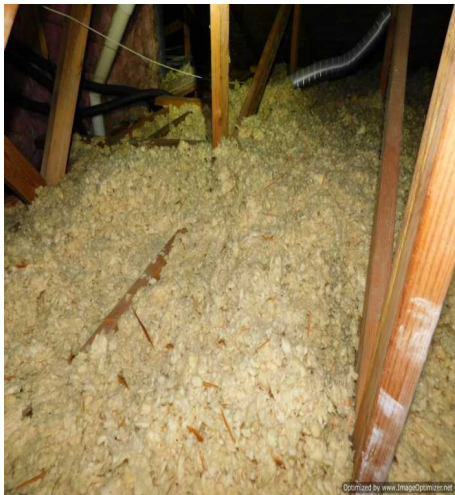
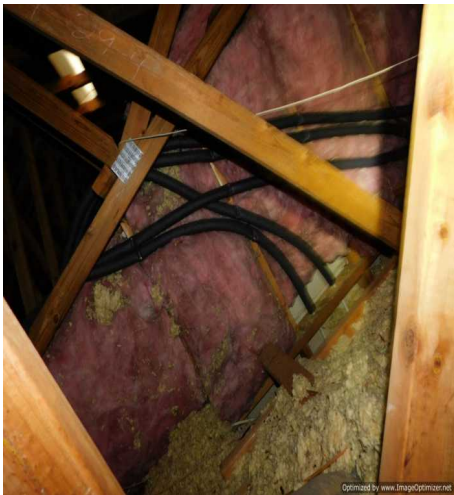
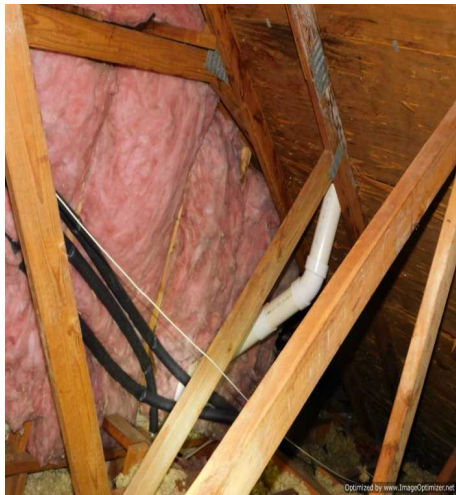
Insulation

Inspected		Satisfactory	
Materials	Fiberglass batt and blown in	Thickness	8-10 inches
Comment	No concerns were observed.

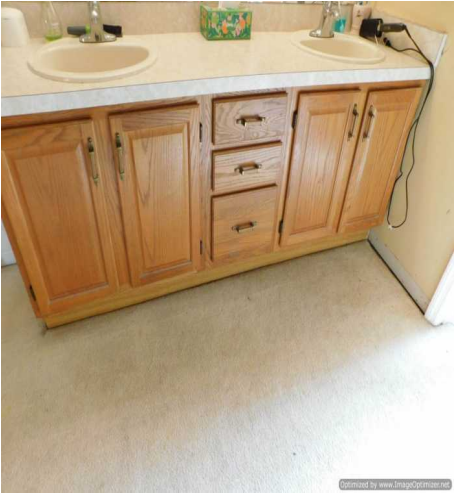
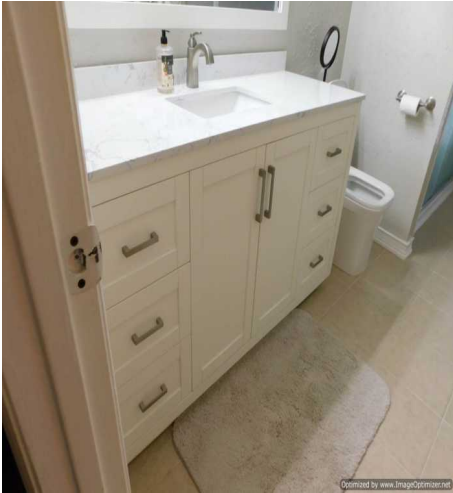
Bathroom Cabinets

Inspected	Satisfactory
Materials	Wood
Comment	No concerns were observed.

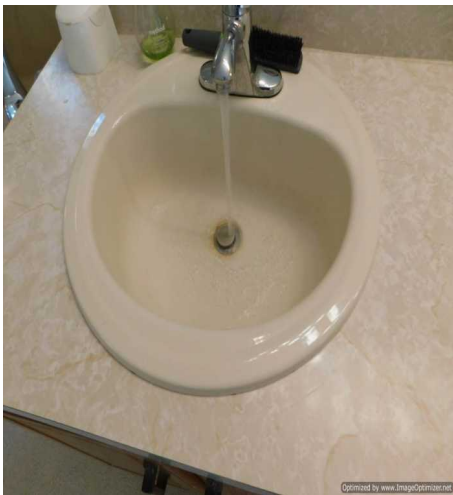
Correction Needed		Recommend Replacement	
Sink Stopper	Yes	Hot/cold lines are reversed	No
Comment	One master bathroom sink needs to be replaced - Rusted.

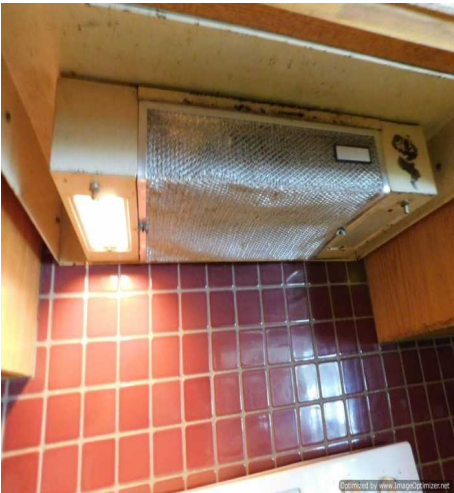
Microwave/ Exhaust

Monitor Conditions		Recommend Repair	
Location	Kitchen	Brand	Veint-Air
Comment	The unit is older and one light was not functional.

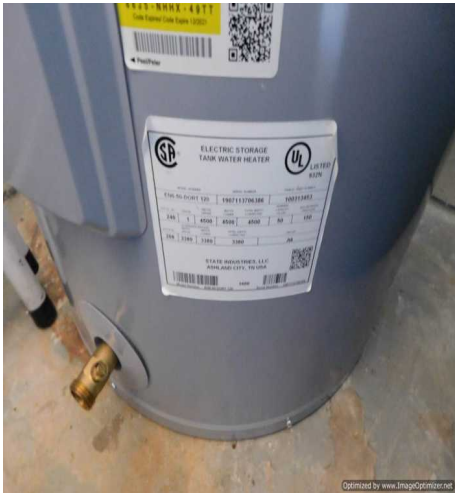
Water heater system

Inspected		Satisfactory	
Brand	State	Year	2019
Type of system	Conventional Storage water	Rusted	No
Fuel type	Electricity	Tank capacity in gallons	50
Location	Garage	Water heater covered in insulation	No
Comment	No concerns were observed.

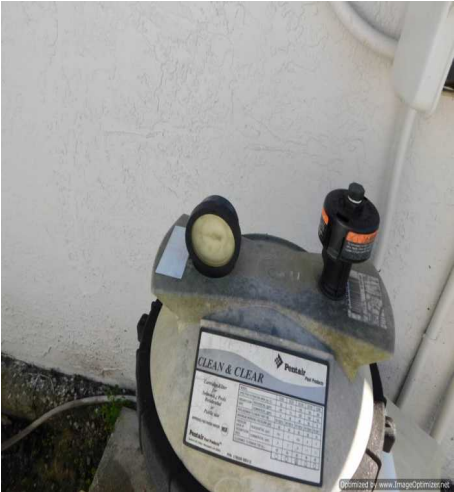
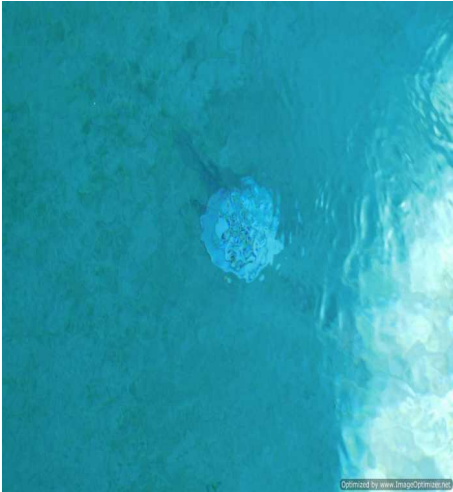
Pressure Gauge/ Drain covers

Monitor Conditions	Recommend Repair
Yes	
Comment	No drain release pipe was observed on the exterior of the pool.

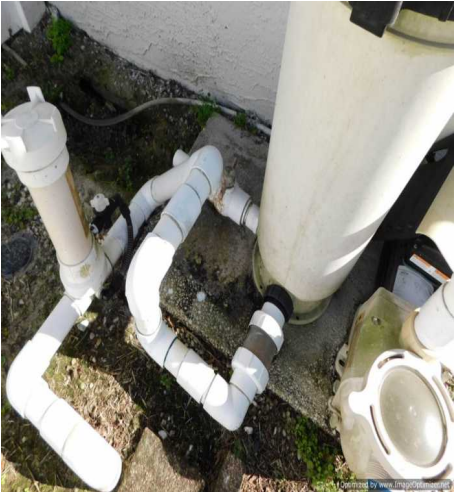
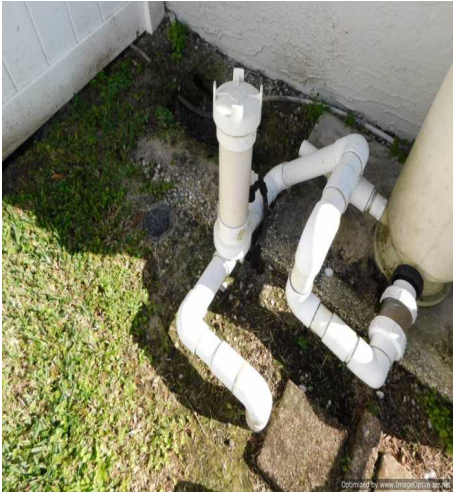
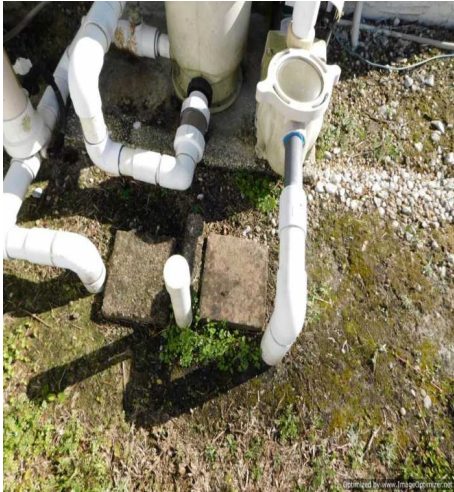
Pool Plumbing

Inspected	Satisfactory
Material	PVC piping
Comment	No concerns were observed.

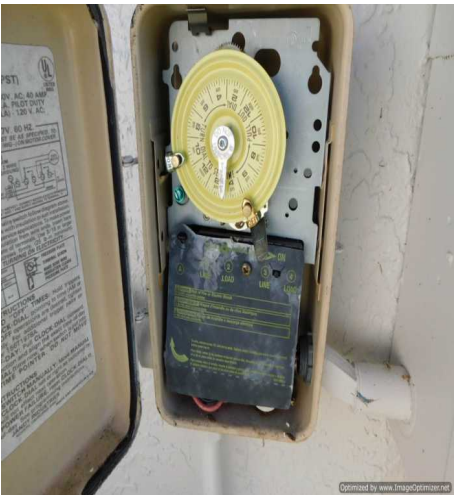
Timer

Inspected		Satisfactory	
Type	Single Enclosure unit (240 volt)		
Comment	No concerns were observed.
