Inspection Report

123 Main Street, Orlando, FL 34711

Date: 01/31/24

My Inspection Boss

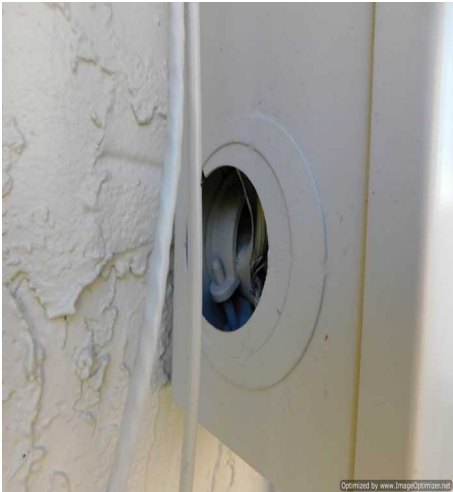
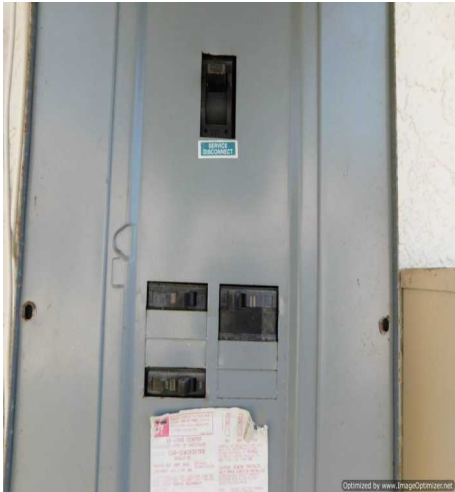
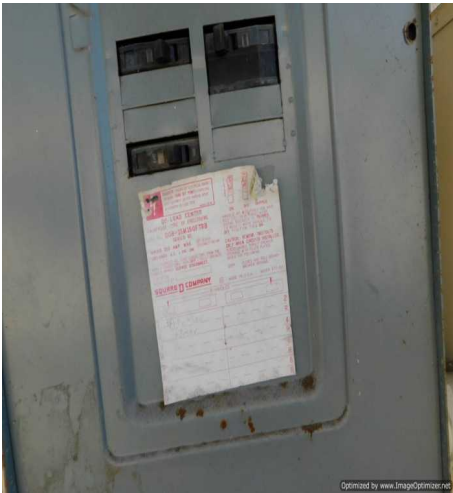
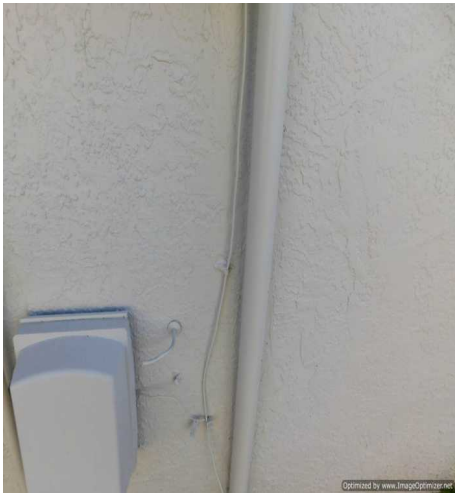
Inspected	Satisfactory / Fair		
Main panel location	Inside of the garage	Main Cut off Switch Location	Main Panel Exterior wall of the home
Service size main panel	120/ 240 Volt	Services connection	Public Utilities (Underground Service)
Type of wiring	Copper	Amp	150 Amp
Grounded	Yes		
Comment	Noted: The hole on the exterior panel should be plugged.

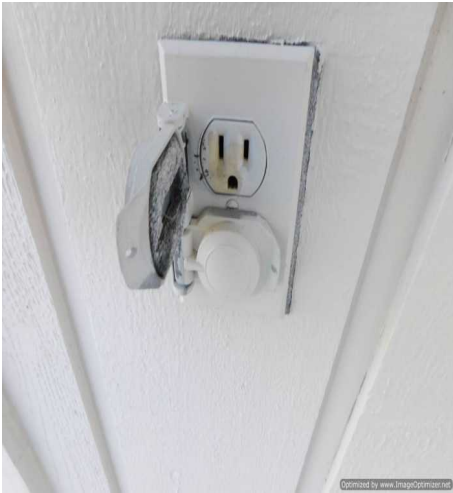
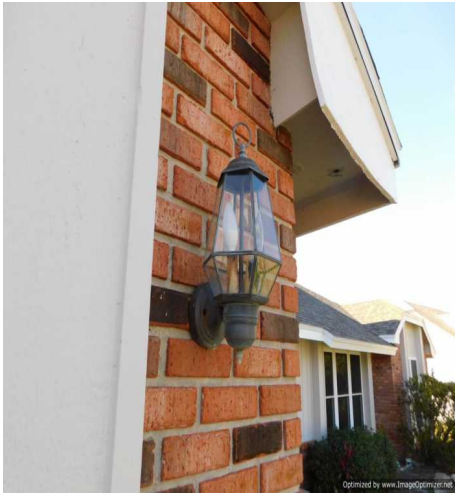
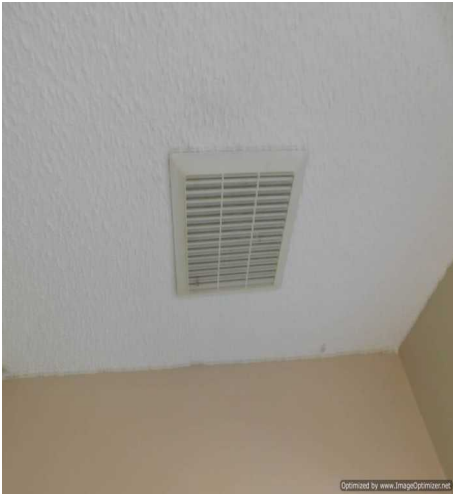
Correction Needed		Repair Needed	
GFCI	Functional	Outlets	3 prong
Smoke detectors	Replace	Door bell	Functional
Comment	The smoke detectors need to be replaced with photoelectric smoke detectors. The exterior fixtures need to be sealed. No GFCI outlets are noted in the wet area of the kitchen.

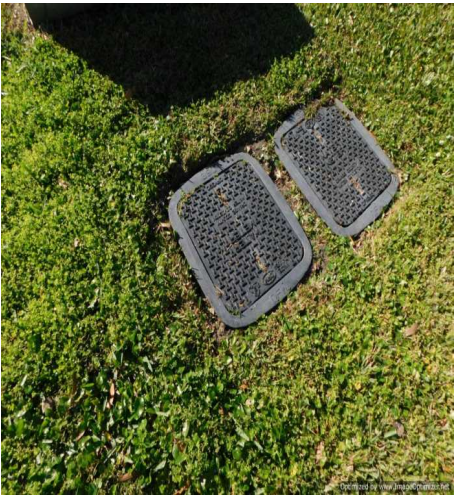
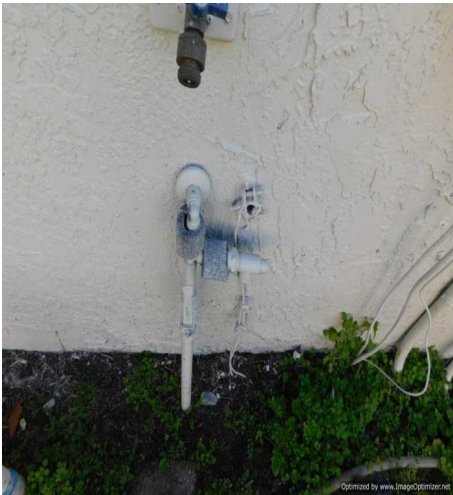
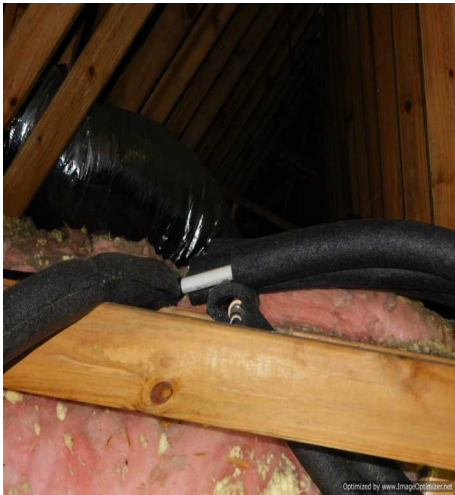
Sewage Supply System

Inspected		Satisfactory	
Location:	Exterior of the home	Drain flow:	Sufficient
Service connection	Public Utilities	Types of drain pipes	PVC piping
Comment	No concerns were observed.

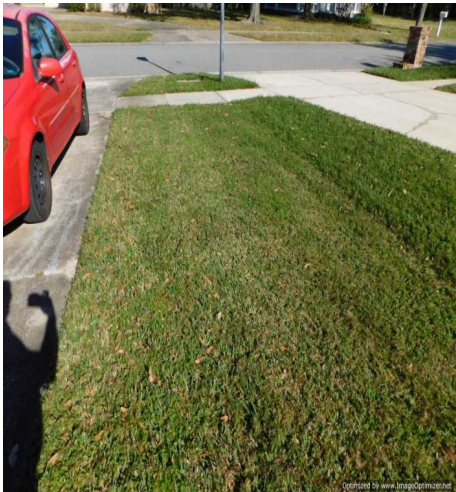
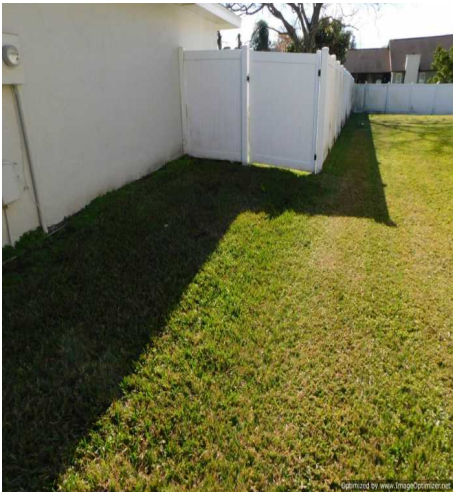
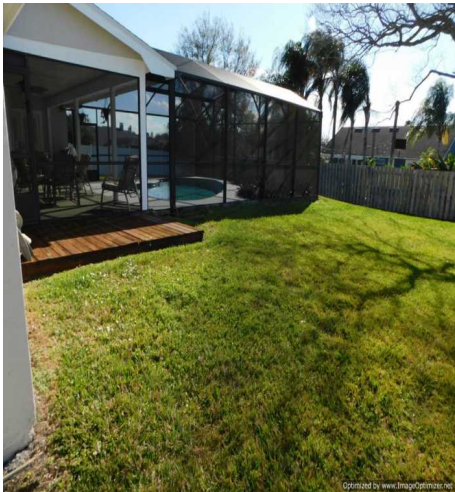
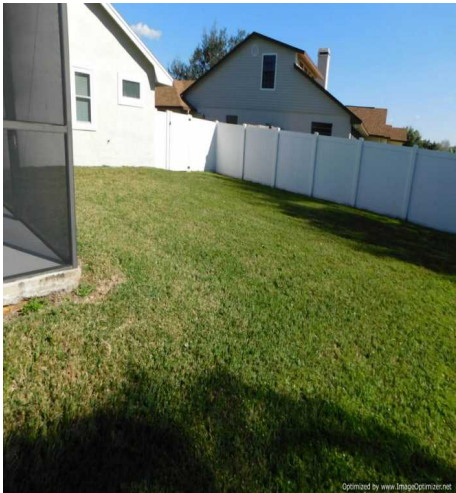
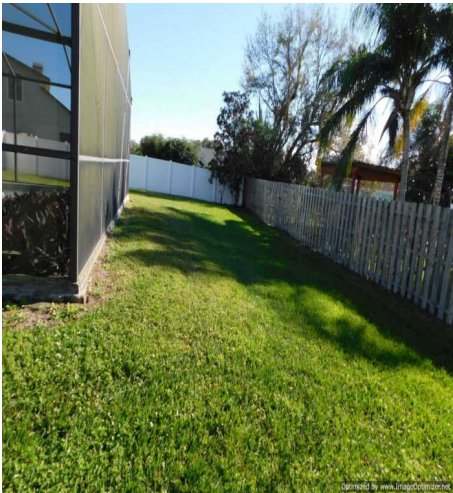
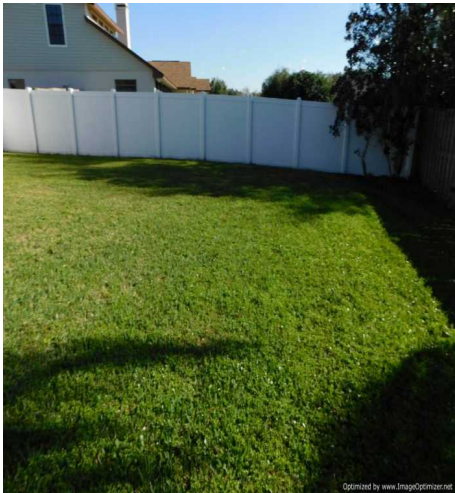
Yard

Inspected	Satisfactory
Material	Grass/Vegetation
Comment	No concerns were observed.

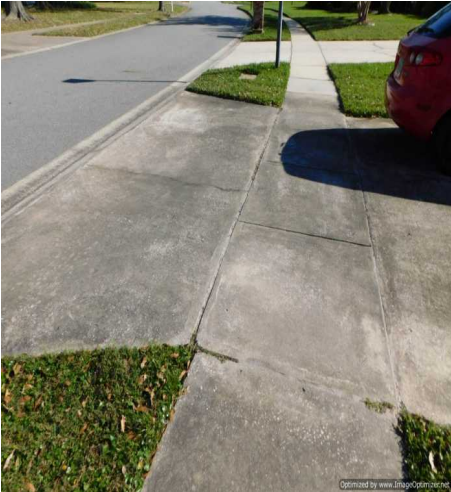
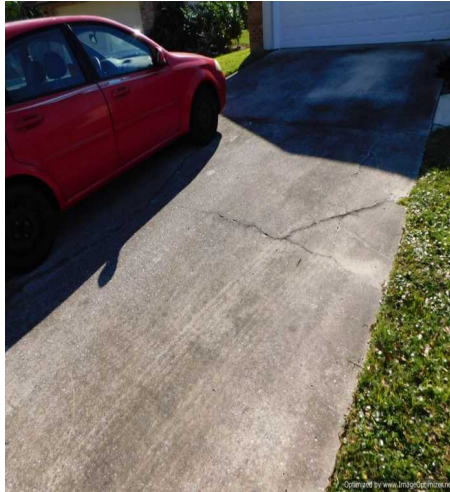
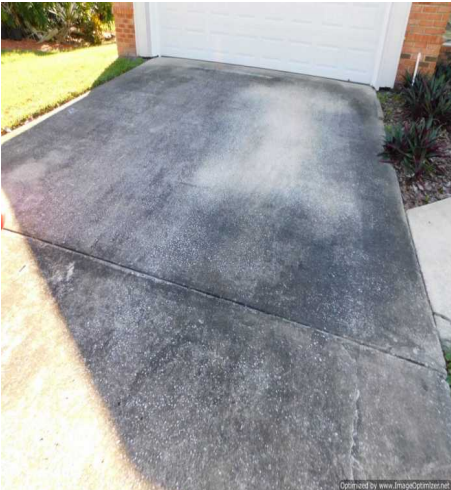
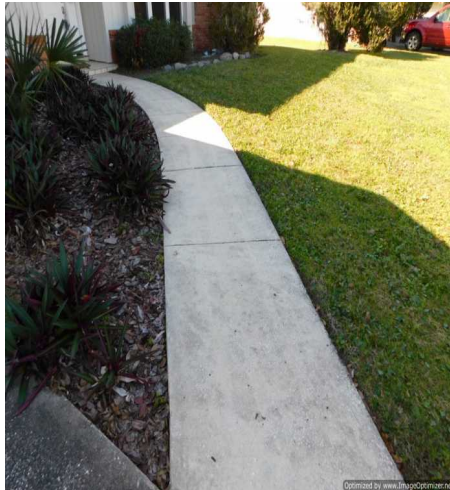
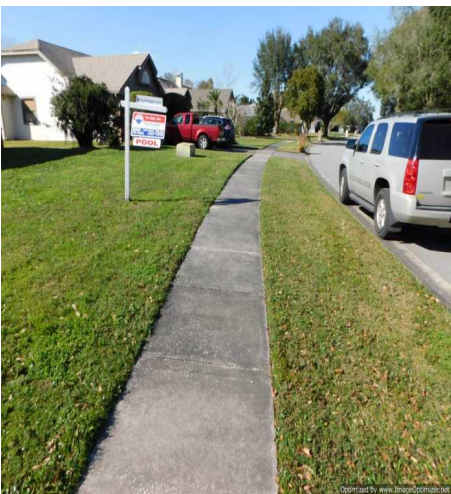
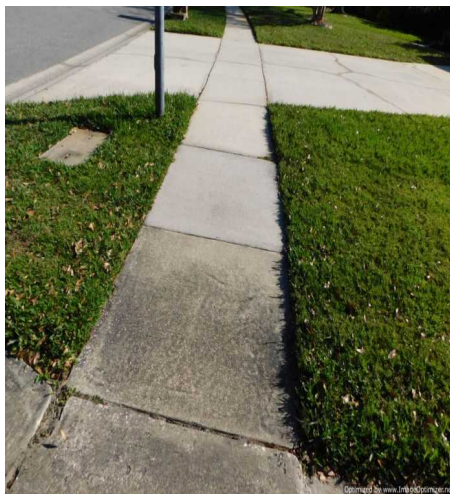
Driveway / Sidewalks

Stress cracks were observed.

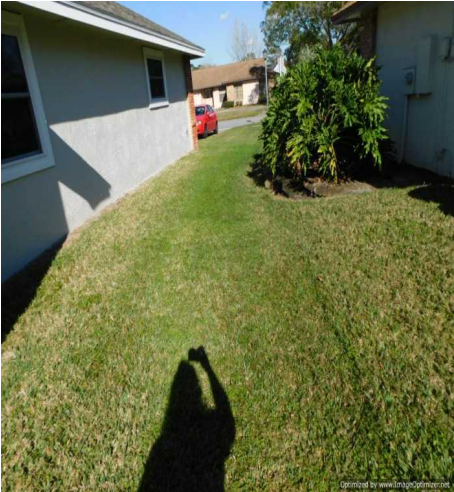
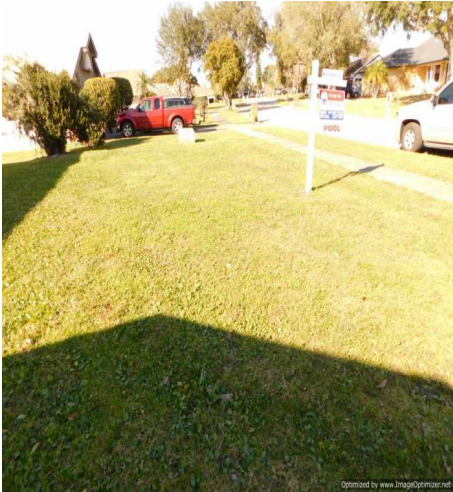
Grading / Slope

Inspected		Satisfactory
Grading issues?	No	
Comment	Noted: Additional gutters are recommended.

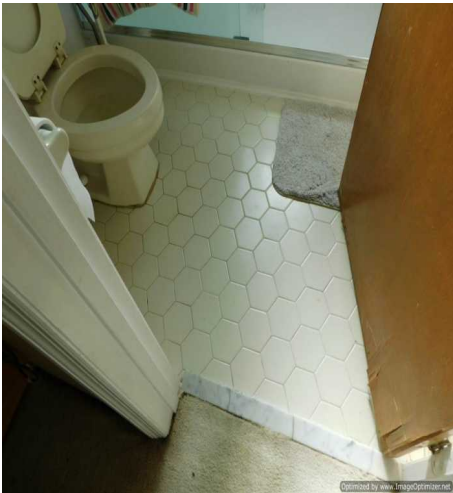
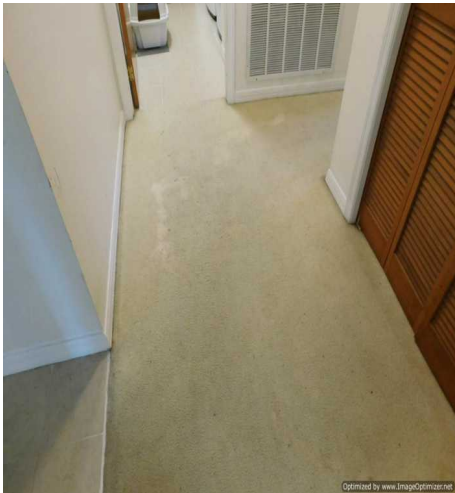
Floors

Correction Needed	Repair Needed
Material	Carpet, Vinyl planking and Tile
Comment	Carpet damage was observed in one bedroom. Carpet stains were noted.

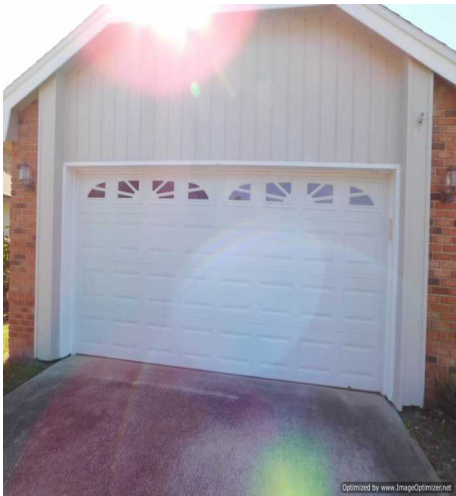
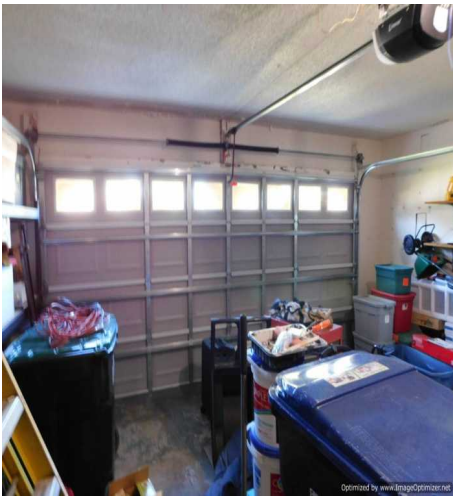
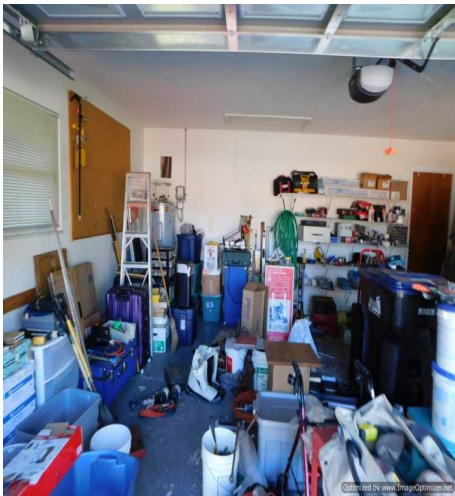
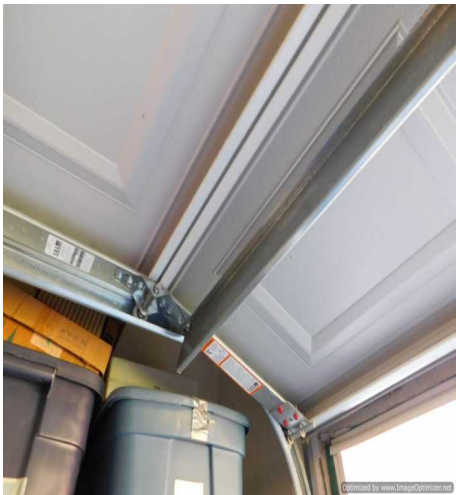
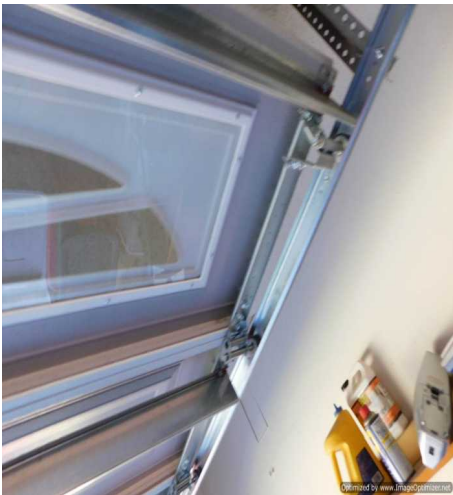
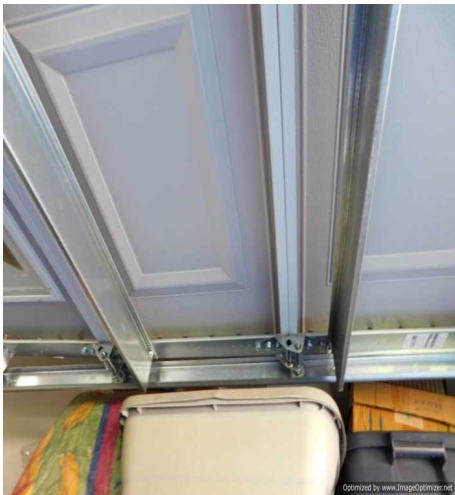
Inspected		Satisfactory / Fair	
Garage door type	Two car garage door (Metal)	Garage door type 2	Attached
Door operation	Automatic Functional	Auto Reverse	Functional
Vent Screens	None	Door Jambs	Satisfactory
Gasket	Complete		
Comment	Minor concrete settling cracks were observed. Noted: The rails and the rollers should be lubricated. Limited inspection due to owner's belongings.

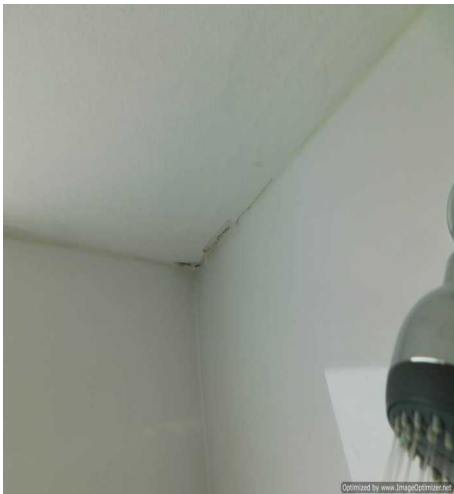
Walls (Interior)

Correction Needed	Minor Repair Needed
Material	Drywall
Comment	Minor holes throughout. The wall needs to be repaired above the water heater. Noted: The fireplace should be cleaned by a professional.

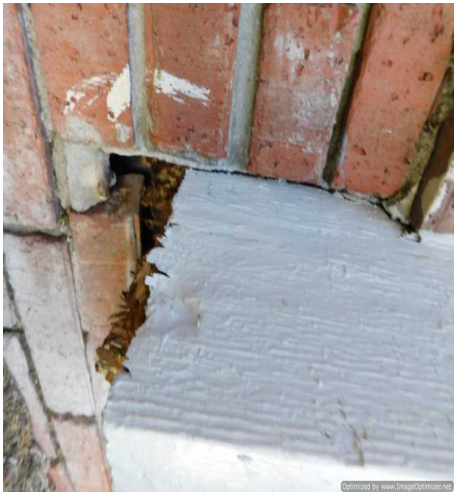
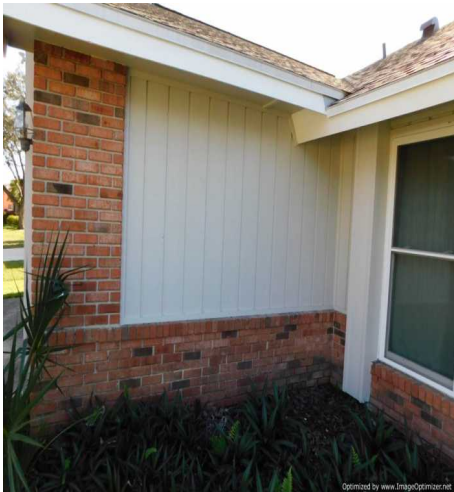
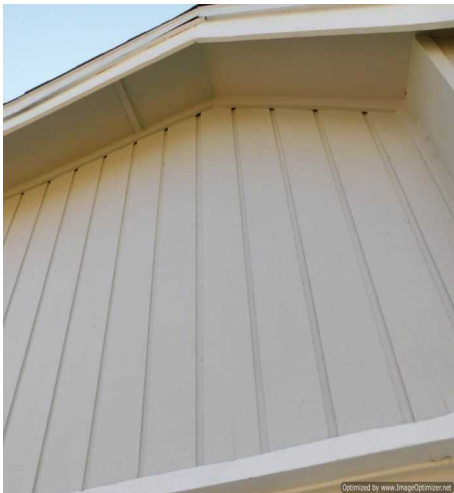
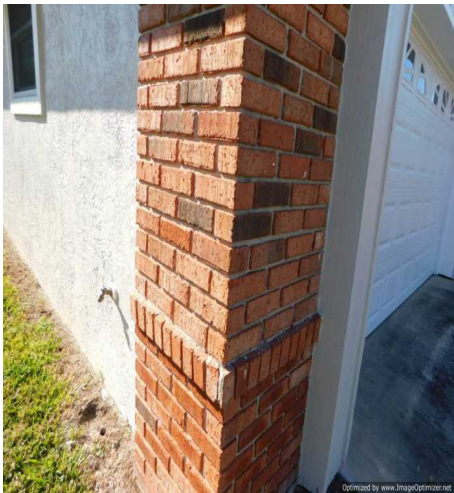
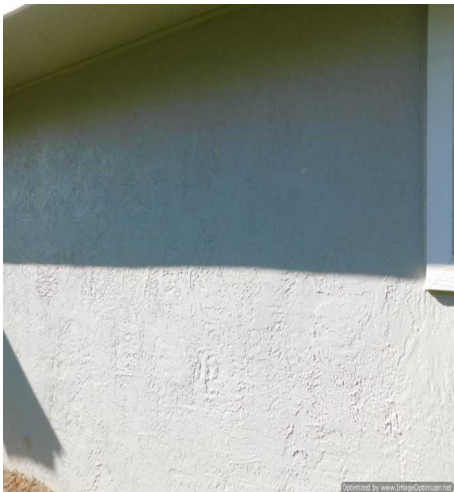
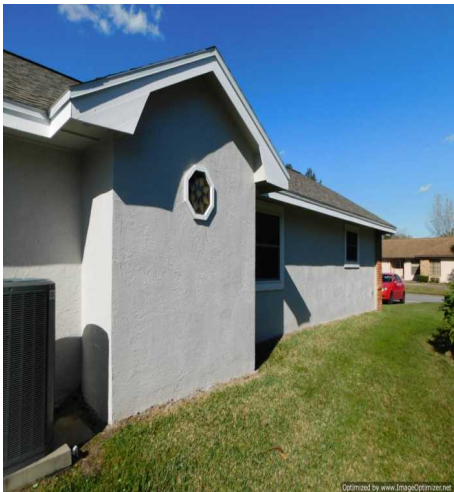
Walls (Exterior)

Monitor Conditions		Recommend Repair	
Material	Stucco, Brick and Wood siding		
Comment	The front wood side post next to the windows should be sealed at the bottom.

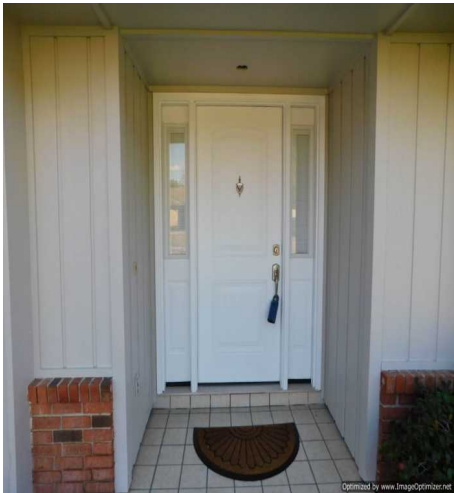
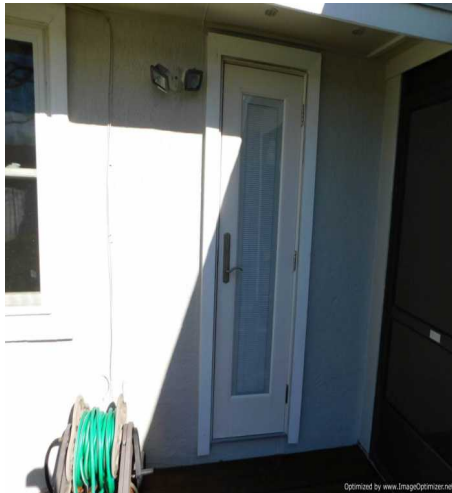
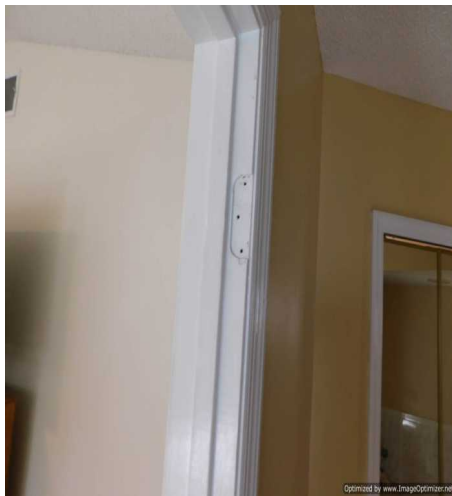
Door(s) (Interior & Exterior)

Monitor Conditions		Recommend Repair	
General Condition of Doors	Satisfactory		
Interior room door condition	Inspected	Interior room door type:	Hollow core (flat panel)
Front home door condition	Inspected	Front home door type	Metal
Exterior door/slider condition	Inspected	Exterior door/ slider type	Metal/Glass
Closet door condition	Inspected	Closet door type	Bifold and Panel
Comment	2+ Interior door stops are missing. Noted: A interior door was missing from the master bedroom to the bathroom.

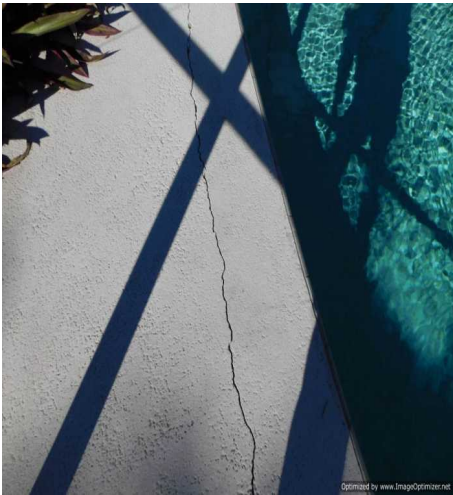
Pool Enclosure/ Patio

Correction Needed	Repair Needed
Material	Metal, Aluminum and Concrete
Comment	Concrete settling cracks were noted - One patio's edge was spray-foamed on the exterior. The cracks need to be sealed - Ask the seller for documentation. Sill plates need securing - 3+ Bolts are rusted/missing. 2+ Tie-downs need adjusting.

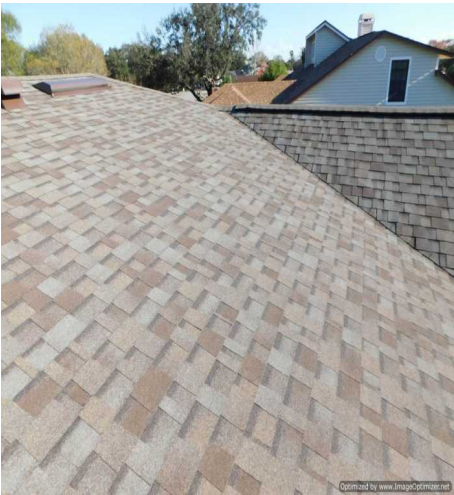
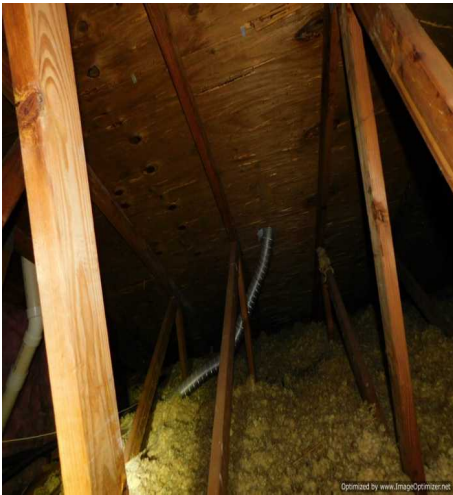
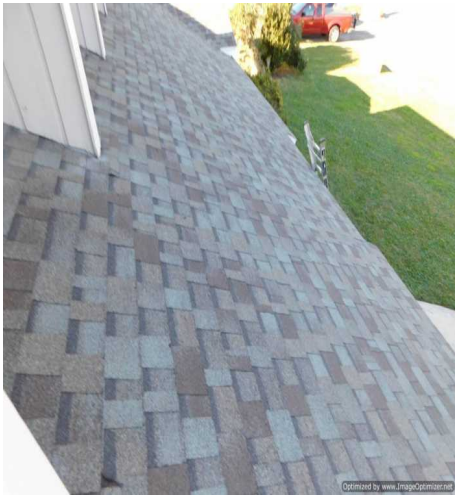
Roof Structure

Inspected	Satisfactory
Is the roof structure satisfactory?	Yes
Comment	No concerns were observed.

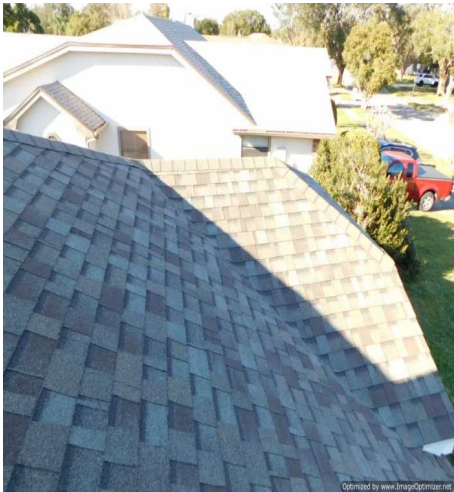
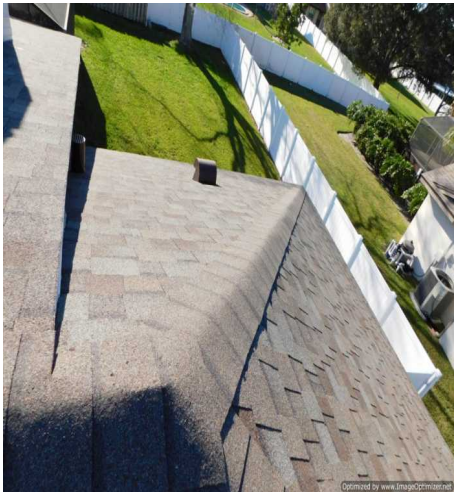
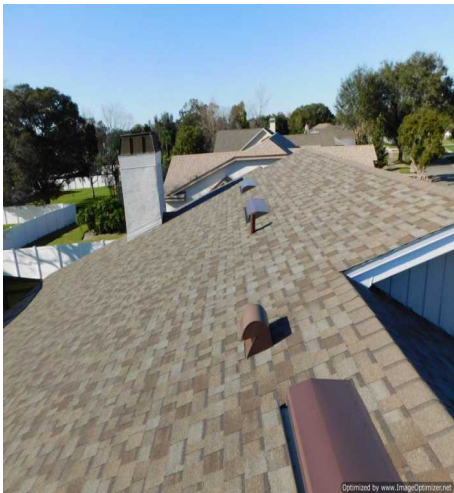
Roof Covering

Inspected		Satisfactory	
Material	Fiberglass Asphalt Shingles	Viewed from	Walking on the roof
Comment	No concerns were observed.

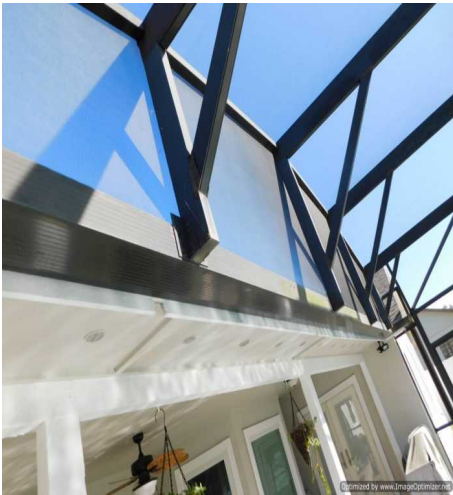
Gutters and Down Spouts

Inspected		Satisfactory
Material	Metal and aluminum	
Comment	Noted: Recommend getting additional gutters.

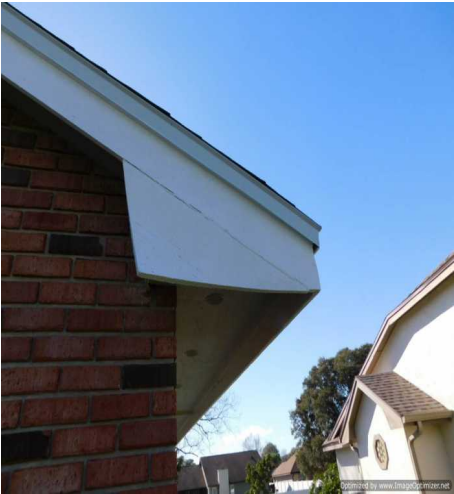
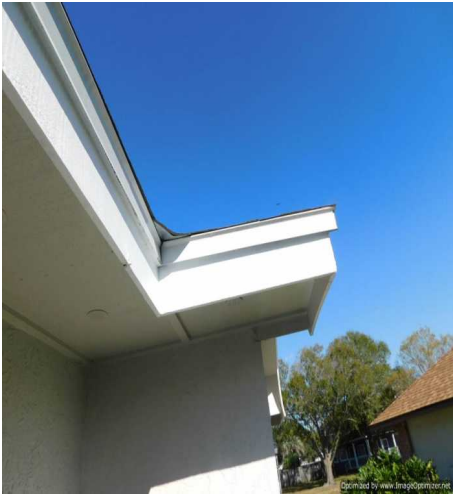
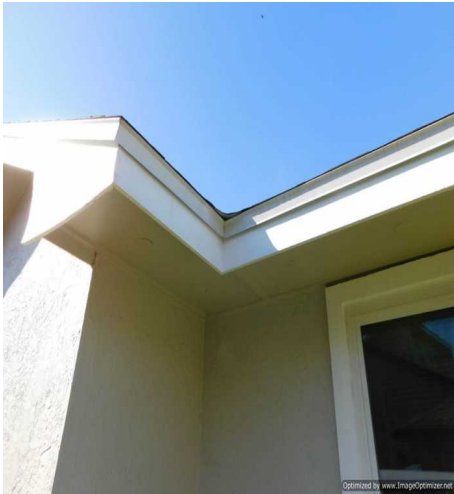
Fascia

Inspected		Satisfactory
Material	Wood	
Comment	No concerns were observed.

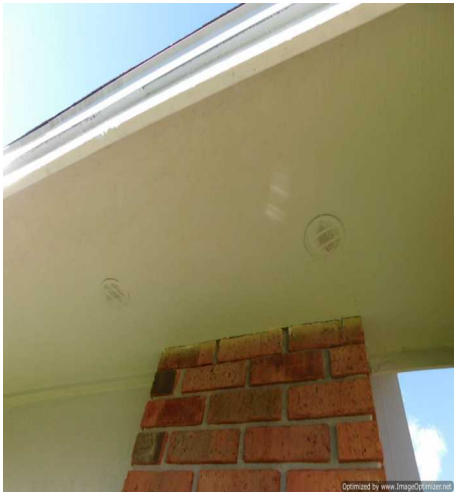
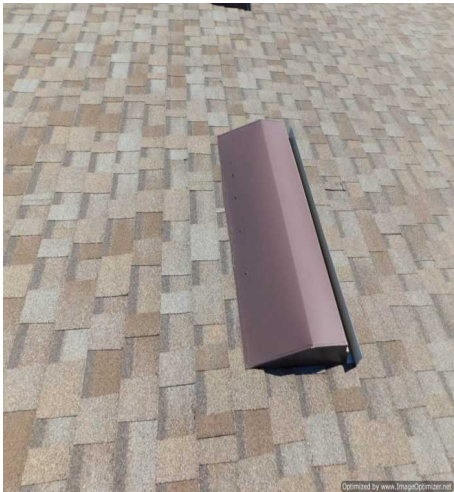
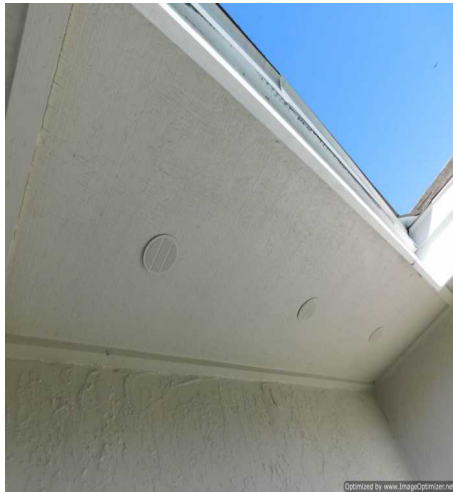
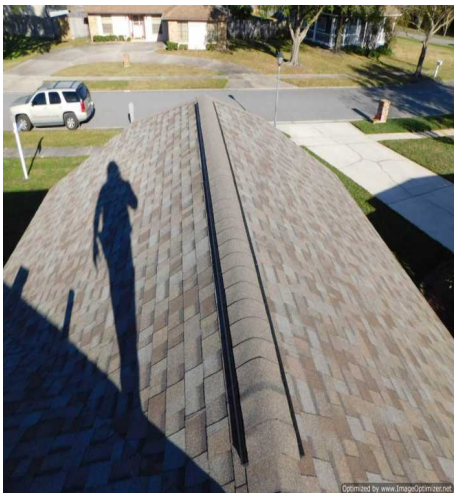
Inspected		Satisfactory	
Ventilation Type	Soffit and Ridge		
Comment	No concerns were observed.		
<div><div>

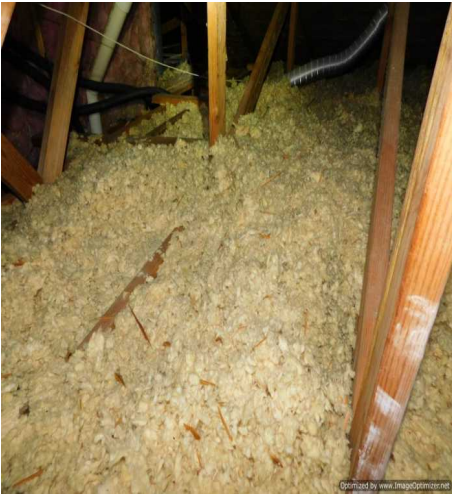
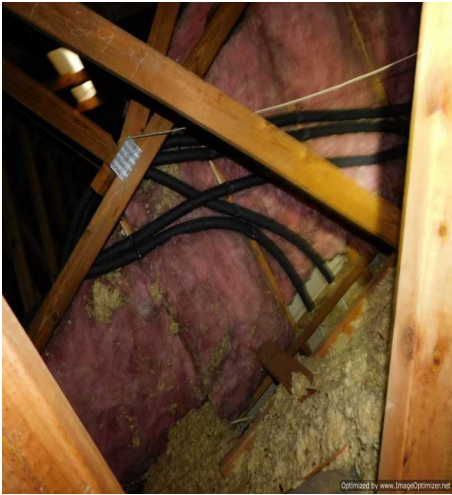
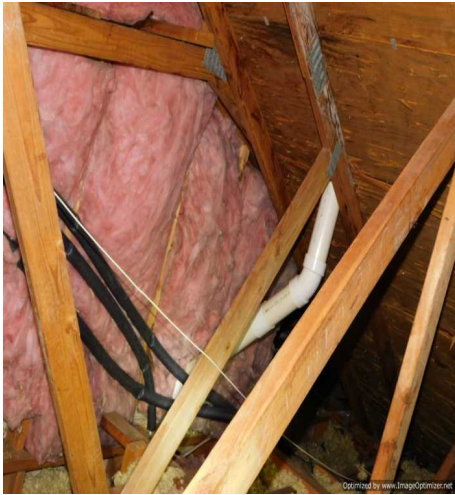
Insulation

Inspected		Satisfactory	
Materials	Fiberglass batt and blown in	Thickness	8-10 inches
Comment	No concerns were observed.

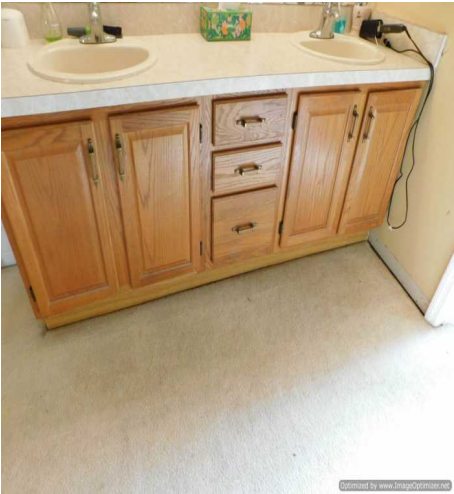
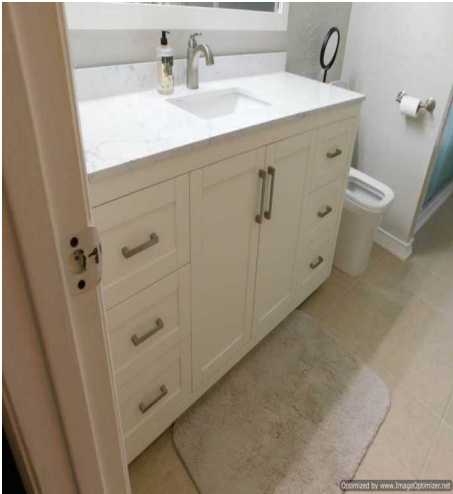
Bathroom Cabinets

Inspected	Satisfactory
Materials	Wood
Comment	No concerns were observed.

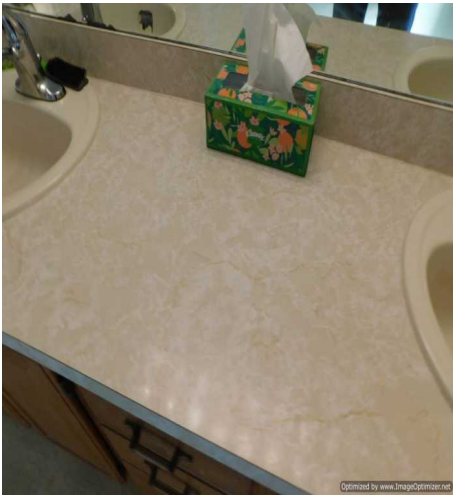
Bathroom Countertops

Inspected	Satisfactory / Fair
Material	Laminate and Faux marble
Comment	No concerns were observed.

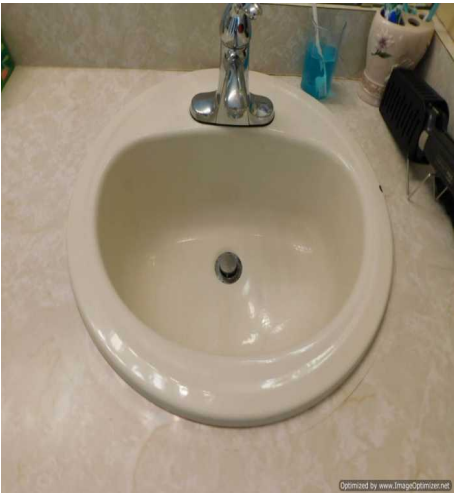
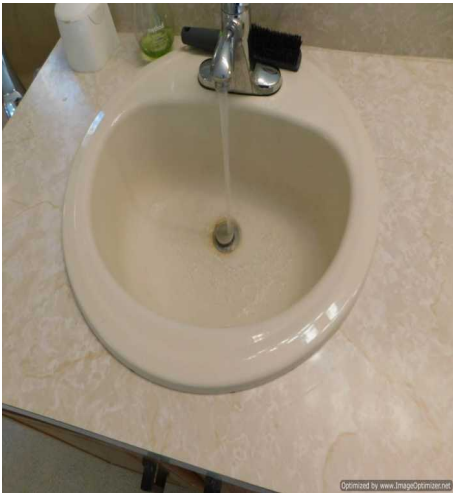
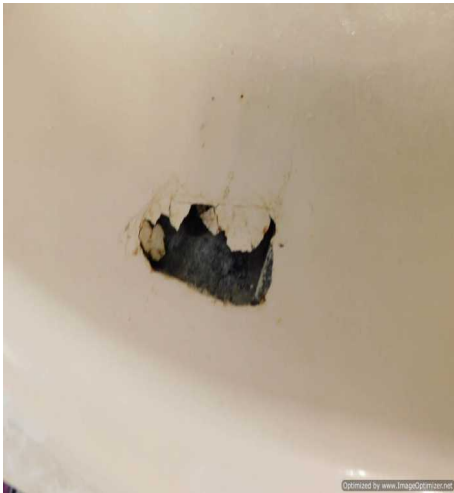
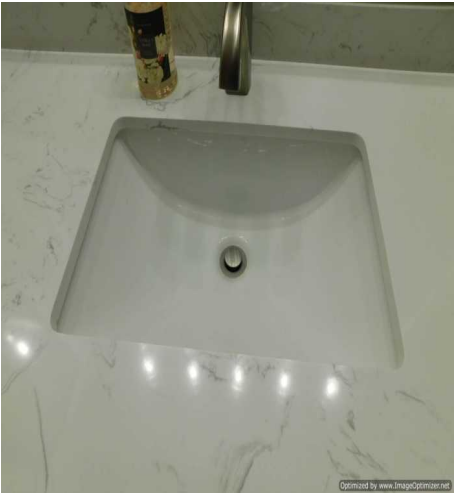
Correction Needed		Recommend Replacement	
Sink Stopper	Yes	Hot/cold lines are reversed	No
Comment	One master bathroom sink needs to be replaced - Rusted.

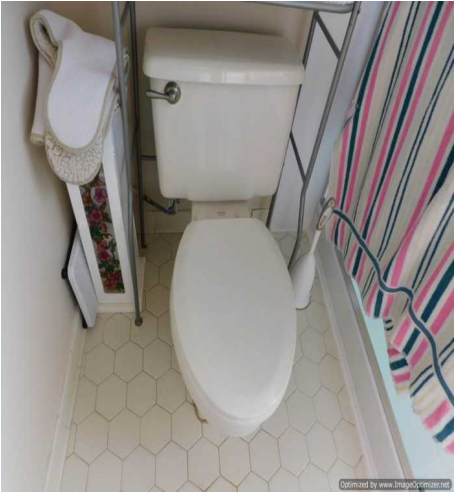
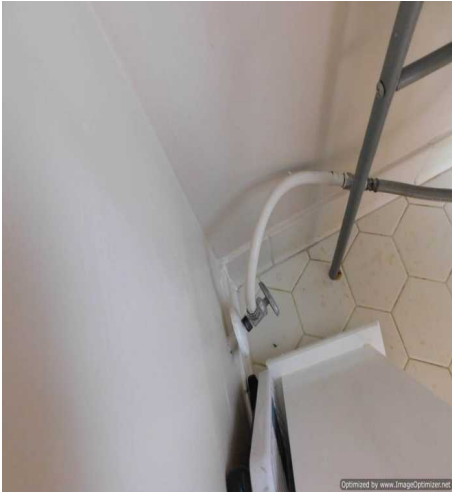
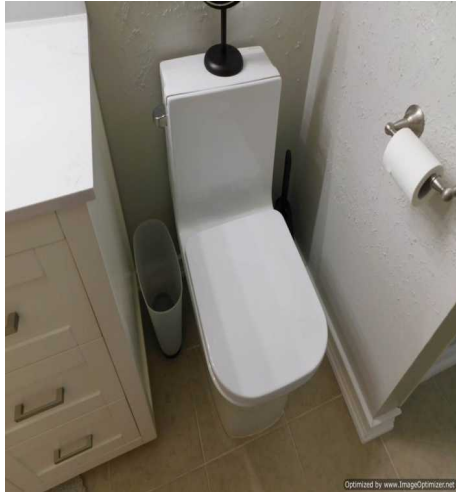
Toilet(s)

Inspected		Satisfactory / Fair	
Type	Porcelain	Toilet secure	Yes
Comment	No concerns were observed.

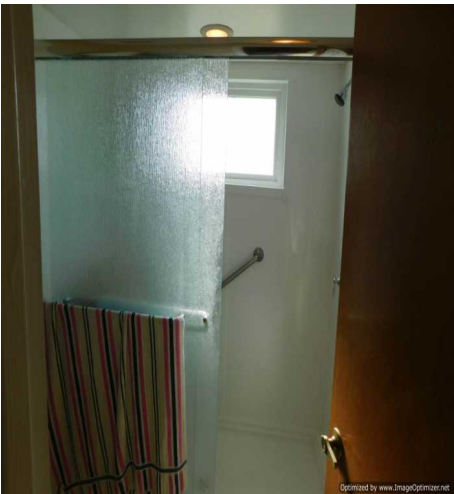
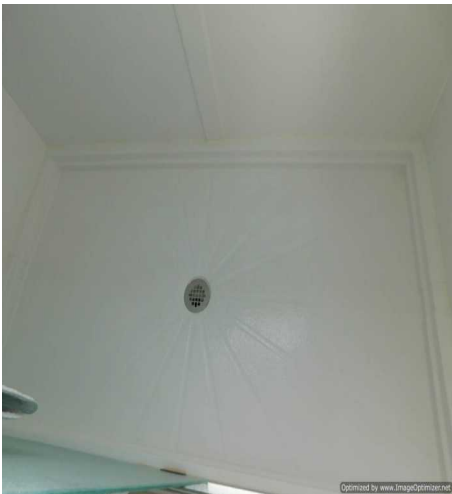
Shower/Tub

Correction Needed		Minor Repair Needed	
Type	Faux Marble and Fiberglass	Tub Stopper	Yes
H/C lines reversed	No	Tub Diverter valve working	Yes
Shower stall needs sealing	Yes	Shower head is missing	No
Comment	The shower and tub surrounds need to be sealed.

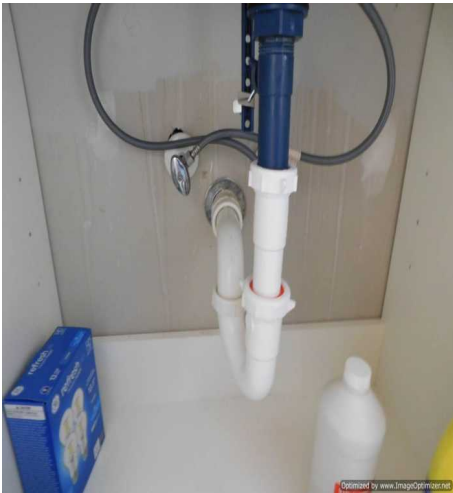
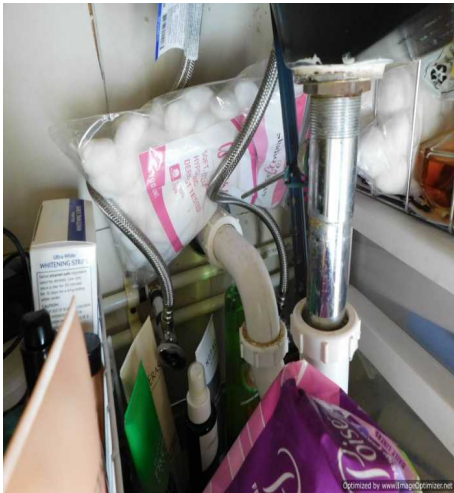
Bathroom Plumbing and Electrical

Inspected		Satisfactory
Material	PVC and PEX	
Comment	Noted: Seal ll the old piping.

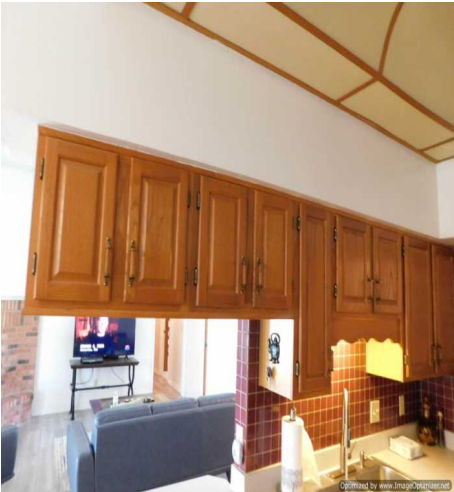
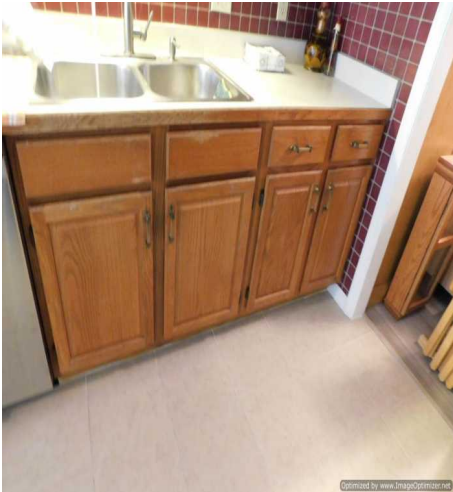
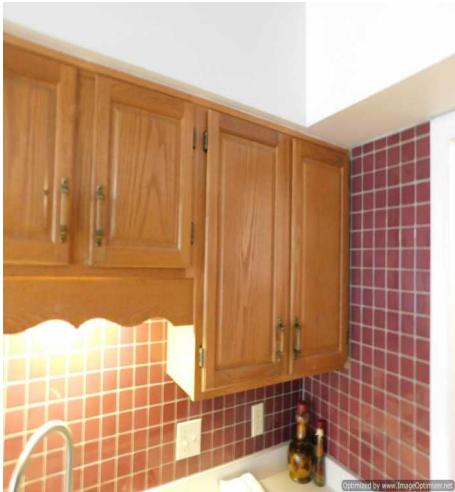
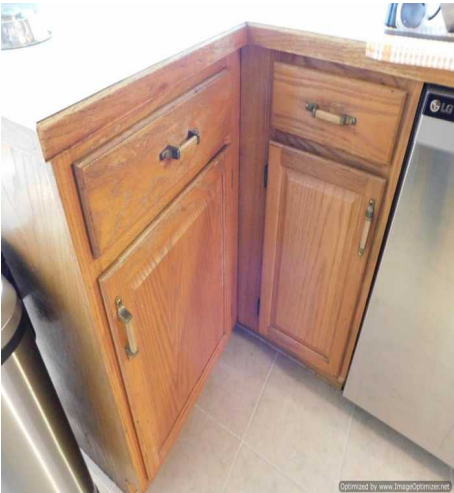
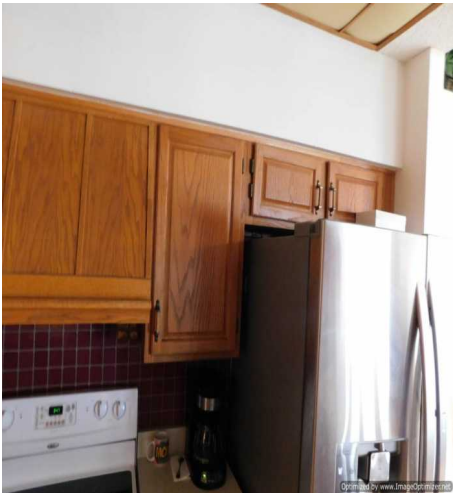
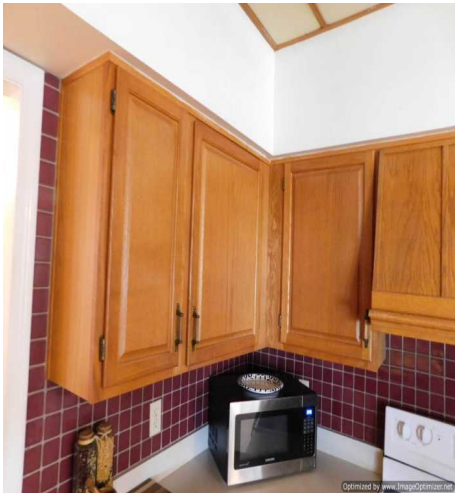
Kitchen Cabinets

Inspected	Satisfactory
Material	Wood
Comment	No concerns were observed.

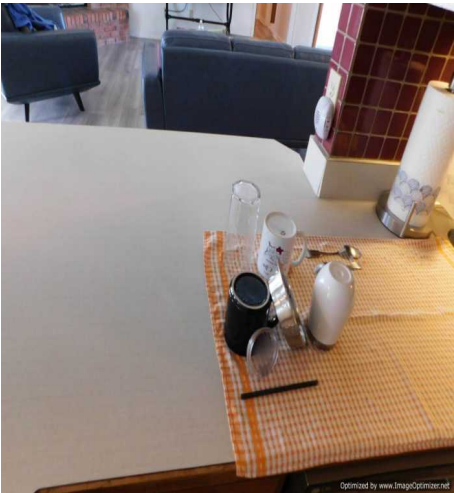
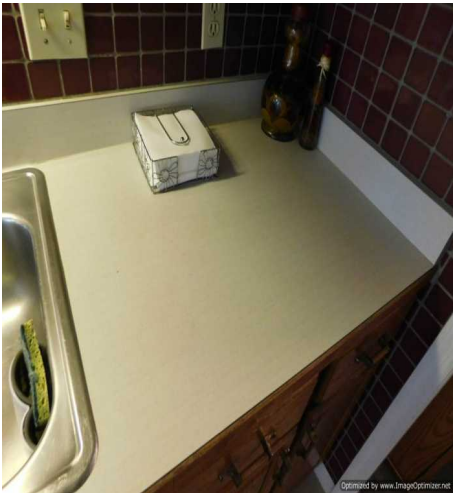
Kitchen Countertops

Inspected		Satisfactory / Fair
Material	Laminate	
Comment	No concerns were observed.

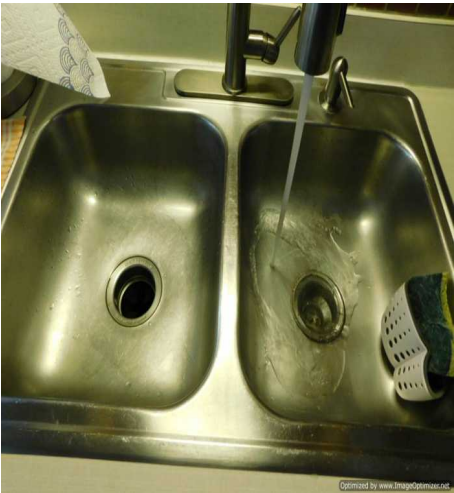
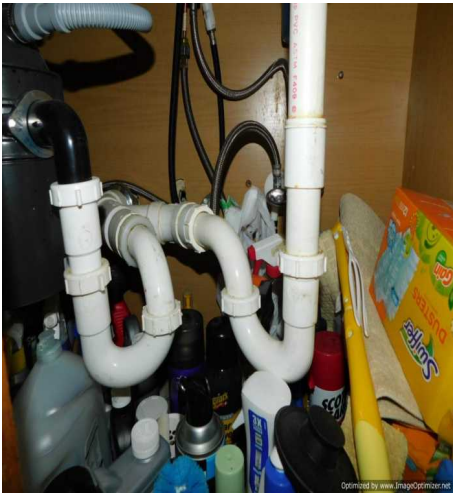
Kitchen Plumbing

Inspected		Satisfactory
Material	PVC and PEX	
Comment	Noted: No GFCI outlet was observed in the wet area.

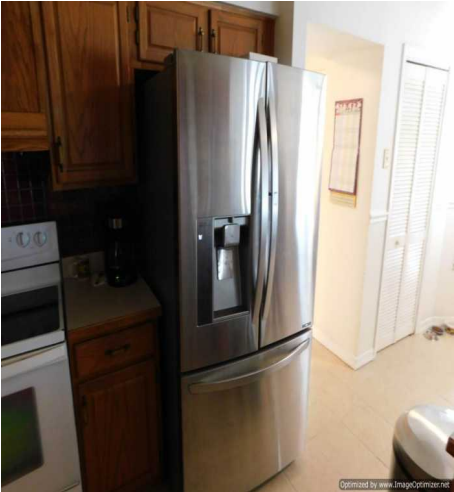
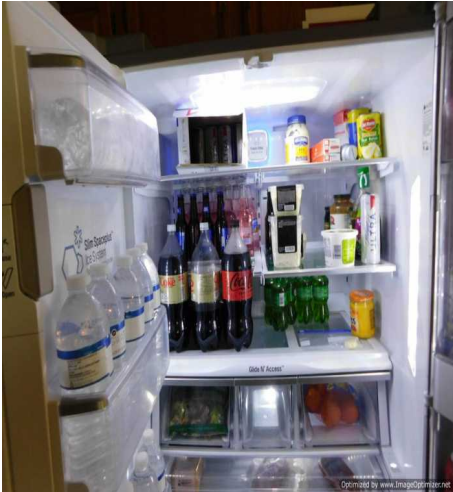
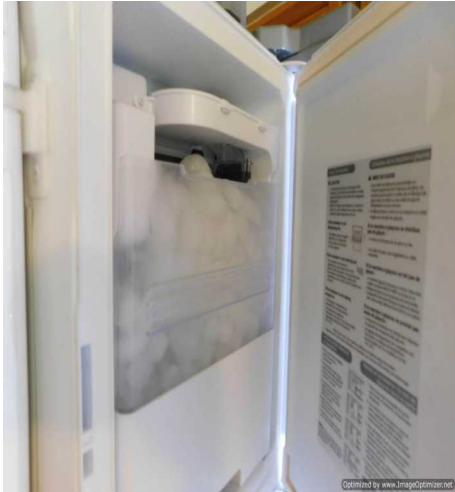
Refrigerator / Freezer

Inspected	Satisfactory
Location	Kitchen
Brand	LG
Comment	No concerns were observed.

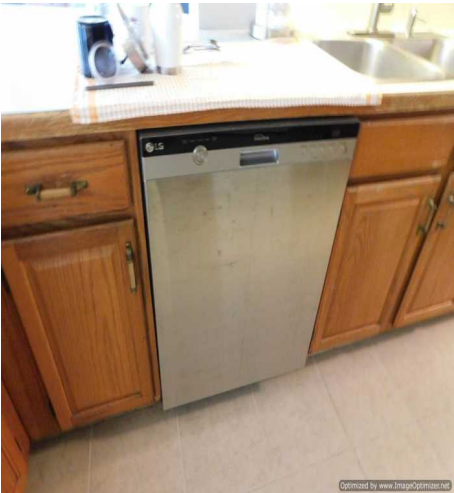
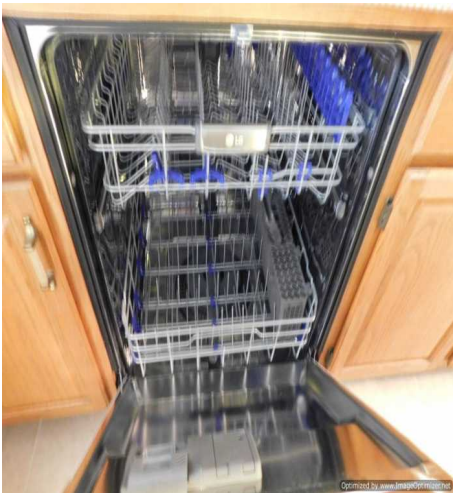
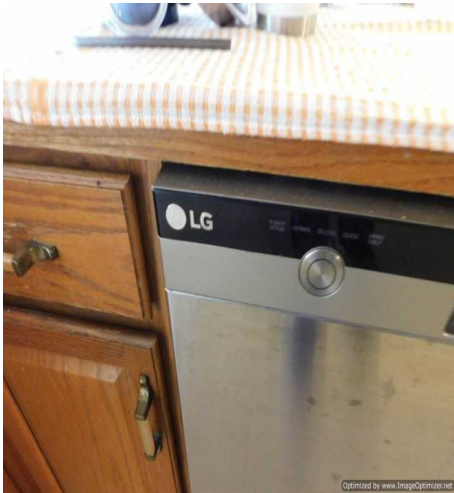
Dishwasher

Inspected		Satisfactory	
Location	Kitchen	Brand	LG
Comment	No concerns were observed.

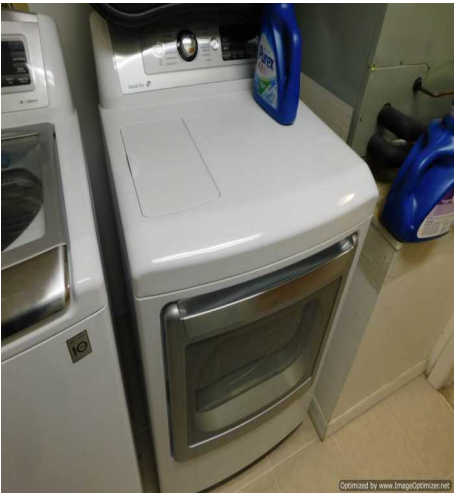
Dryer

Monitor Conditions		Recommend Repair	
Location	Utility room	Brand	LG
Comment	Clean the dryer vent. Noted : the dryer is functional.

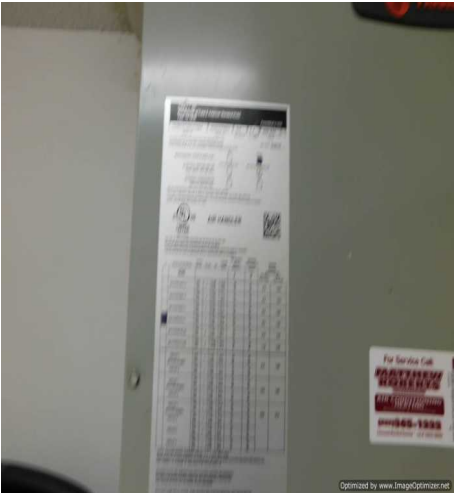
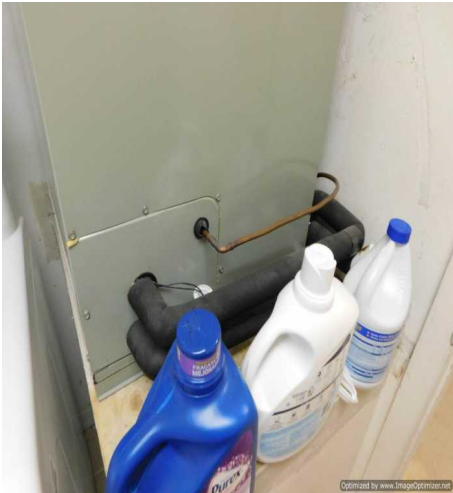
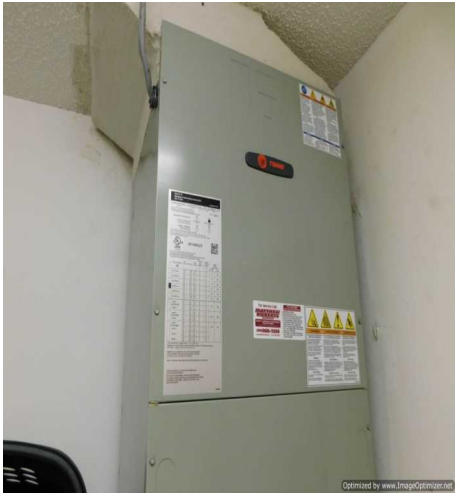
Heating system

Inspected		Satisfactory	
System Name	Trane	Year	2019
Heat source type	Heat Pump	Fuel type	Electricity
Temperature Register	98		
Location	Utility room		
Comment	No concerns were observed.
