Inspection Report

123 Main Street, Orlando, FL 34711

Date: 01/31/24

My Inspection Boss

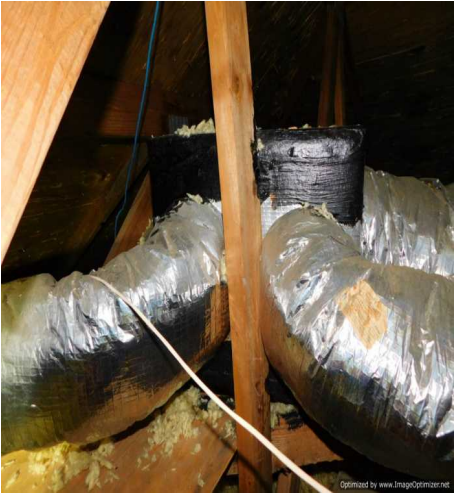
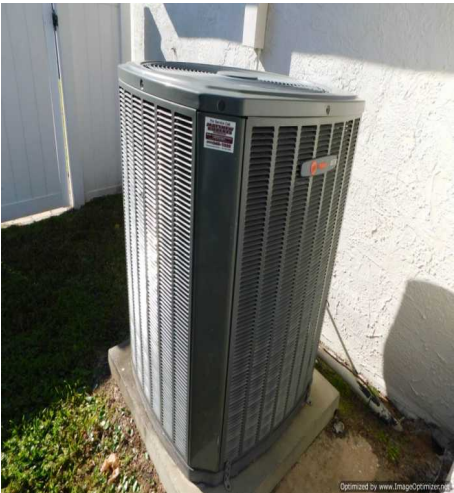
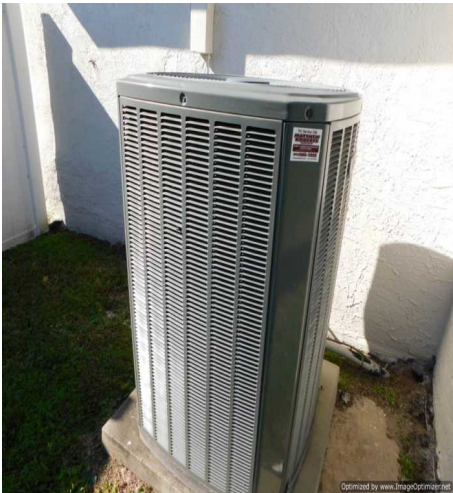
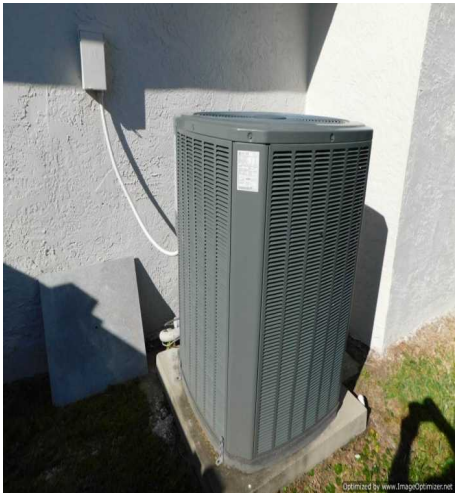
Cooling system

Inspected		Satisfactory	
System Name Compressor	Trane	Year model compressor	2019
System name air handler	Trane	Year model air handler	2019
Cooling type	Central Split	# of zones	1
Location	Yard	A/C differential sufficient	Yes
Temperature at return	71	Temperature at register	53
Filter	Sufficient	Thermostat	Secure
Suction Line insulation	Sufficient		
Comment	Noted: Service the unit annually.

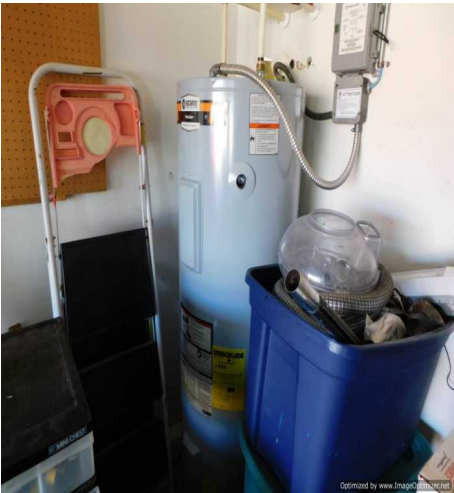
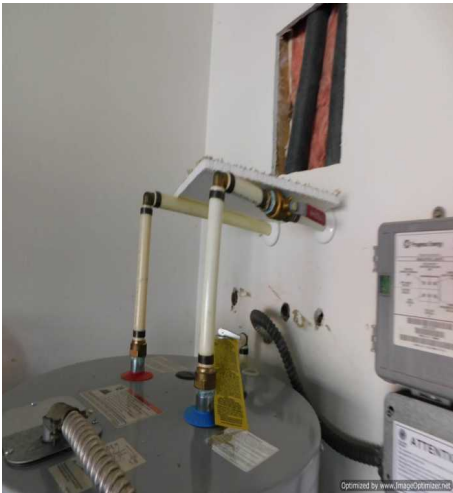
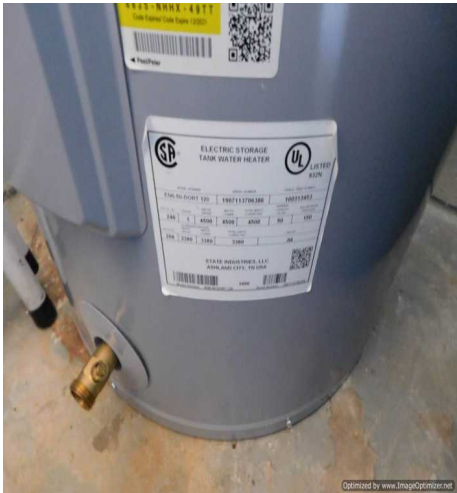
Water heater system

Inspected		Satisfactory	
Brand	State	Year	2019
Type of system	Conventional Storage water	Rusted	No
Fuel type	Electricity	Tank capacity in gallons	50
Location	Garage	Water heater covered in insulation	No
Comment	No concerns were observed.

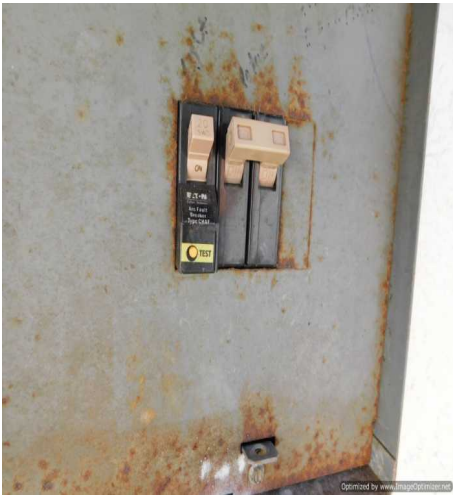
Are there any Electrical/
Lighting issues? No

Comment No concerns were observed.

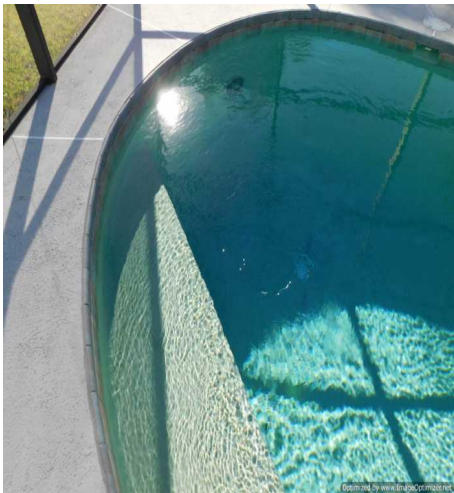
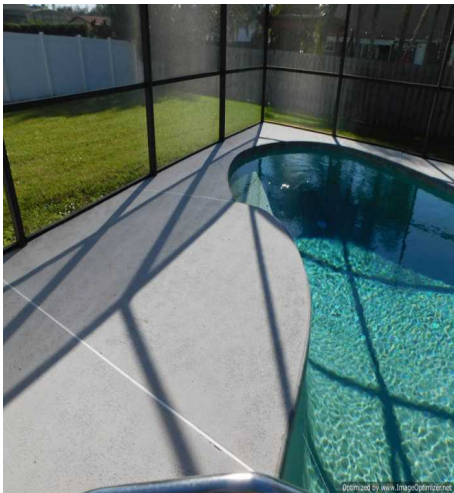
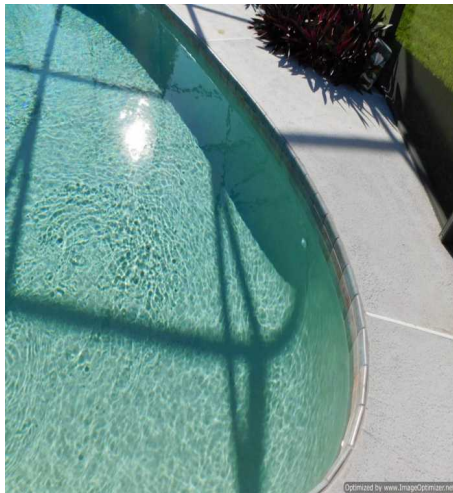
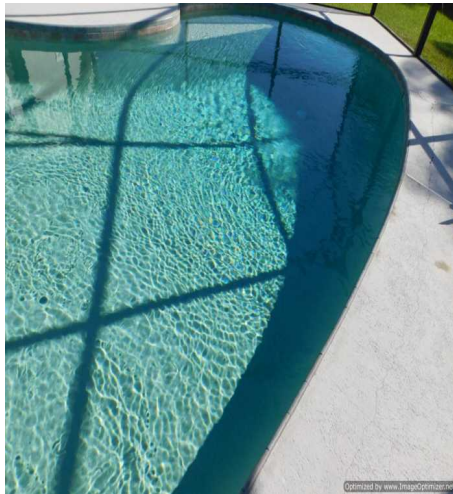
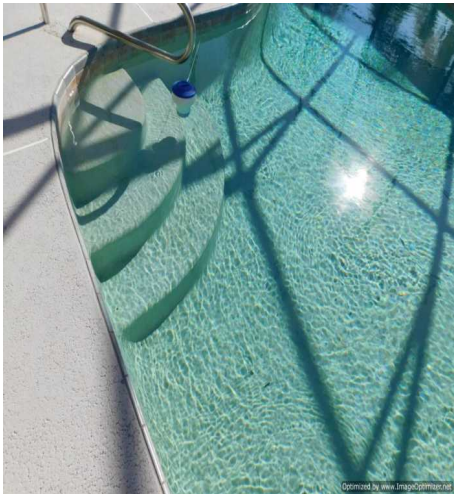
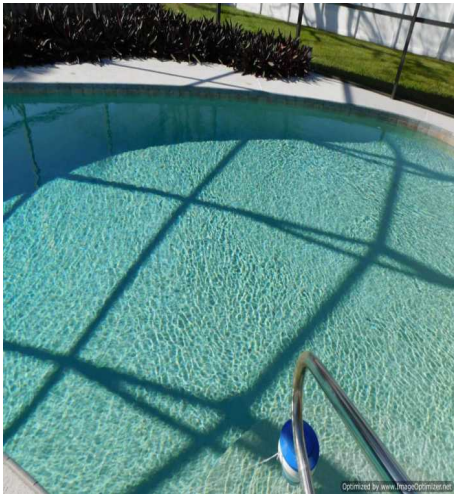
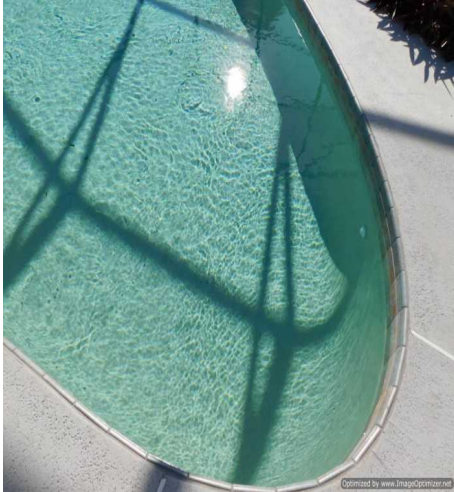
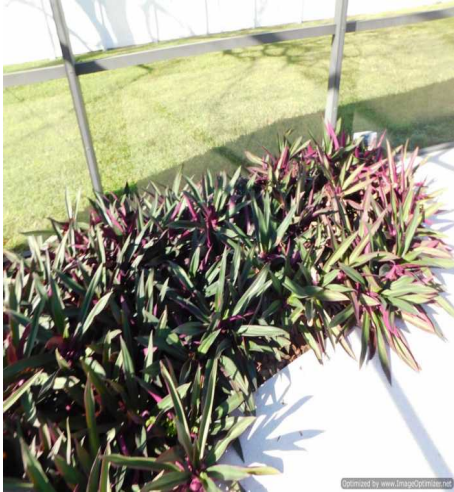
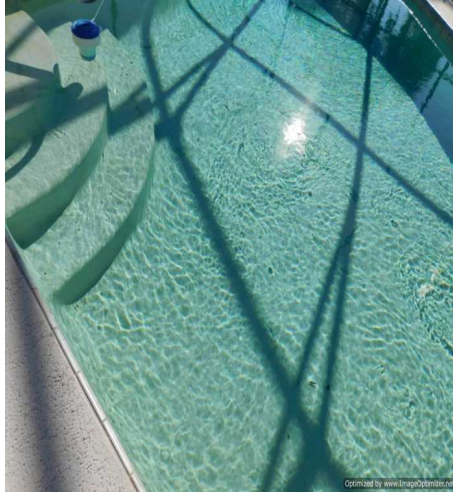
Structure Condition, Decking and Coping

Monitor Conditions		Recommend Repair	
Material	Gunitite and poured concrete		
Comment	Concrete settling cracks were observed on the exterior pool decking. Patches were observed by the main drain on the interior of the pool. Minor stains were observed on the interior pool surface.

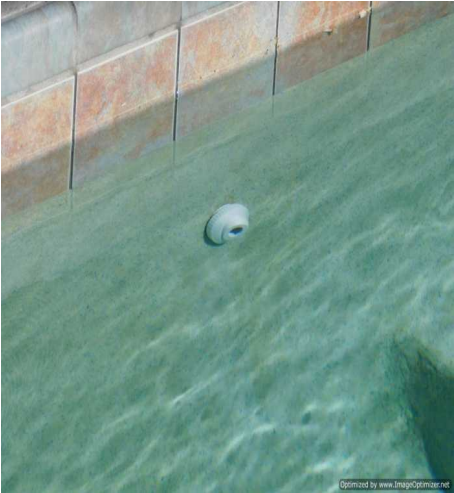
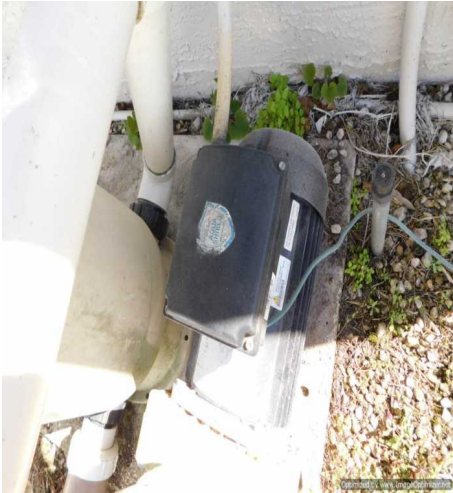
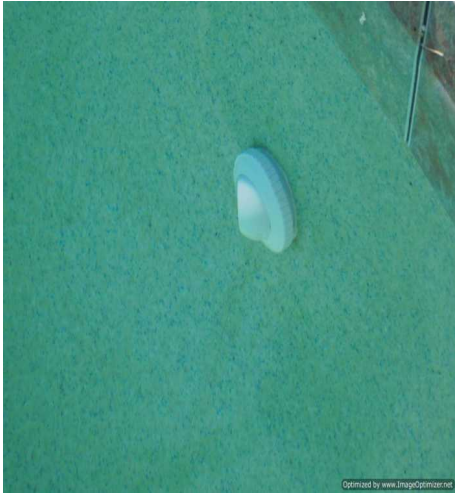
Pump(s) / Jets

Inspected	Satisfactory
Yes	
Comment	No concerns were observed.

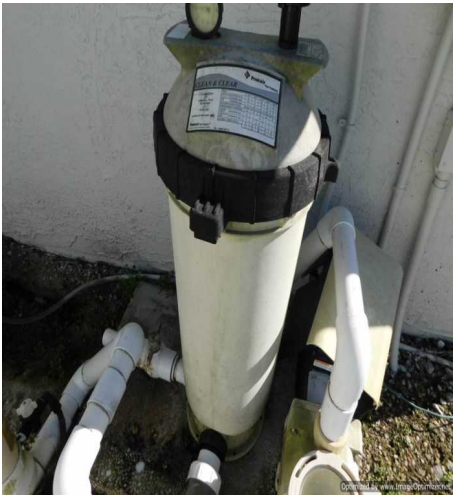
Filter / Skimmer and Basket

Inspected	Satisfactory
No	
Comment	No concerns were observed.

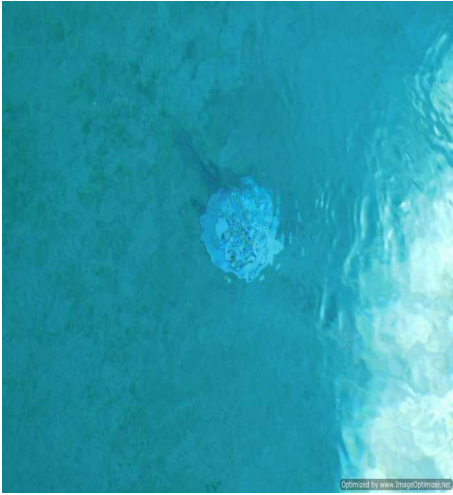
Pressure Gauge/ Drain covers

Monitor Conditions	Recommend Repair
Yes	
Comment	No drain release pipe was observed on the exterior of the pool.

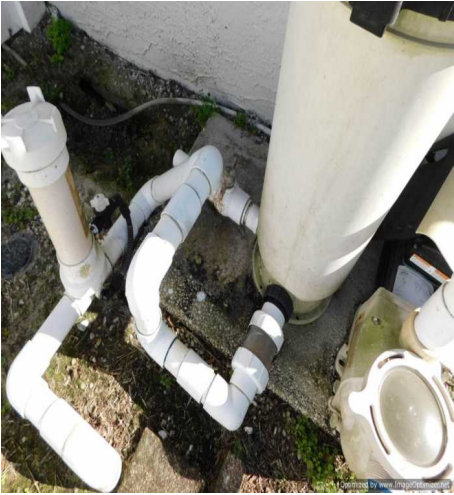
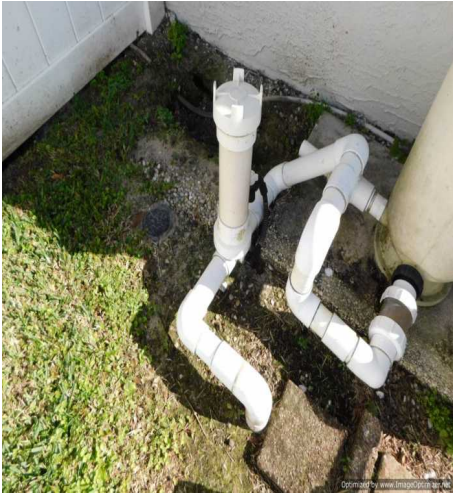
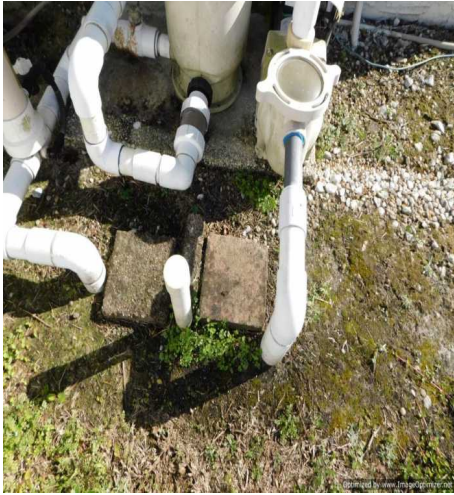
Pool Plumbing

Inspected	Satisfactory
Material	PVC piping
Comment	No concerns were observed.

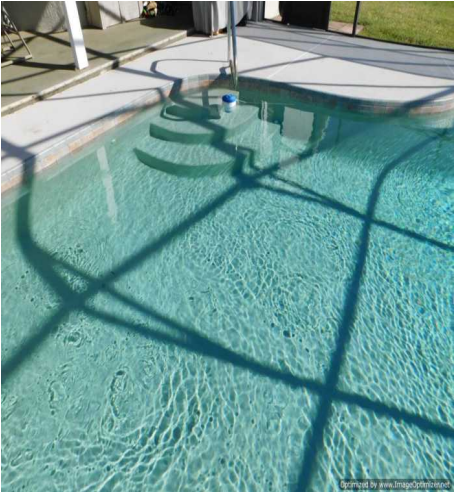
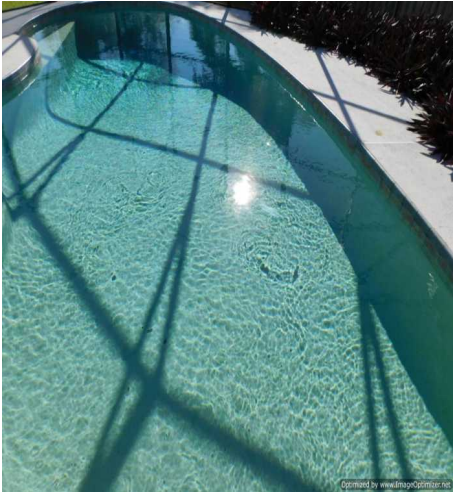
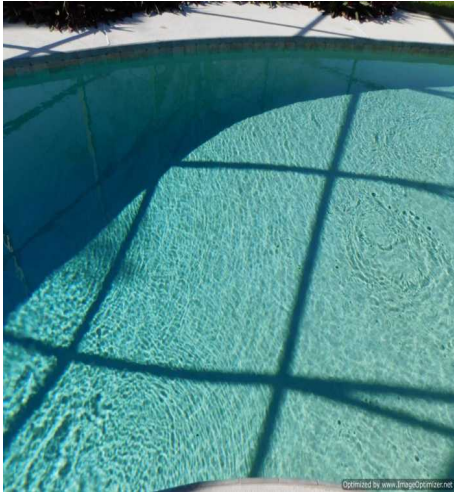
Water Condition

Inspected		Satisfactory	
Water condition	Clear	Water level at the time of the inspection	Normal
Comment	No concerns were observed.

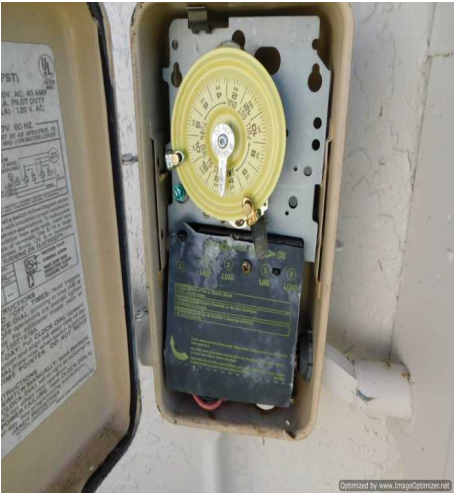
Timer

Inspected		Satisfactory	
Type	Single Enclosure unit (240 volt)		
Comment	No concerns were observed.
